**CLIENT**  
 Folkestone & Hythe District Council

**JOB TITLE**  
 Leas Cliff,  
 Folkestone,  
 Kent.

This report presents the findings of a visual slope stability assessment which was carried out to assess potential reasons for slope failure and assess the possibility of future landslips.

Document no: A124037-TGEE-GEN-XX-RP-C-0001

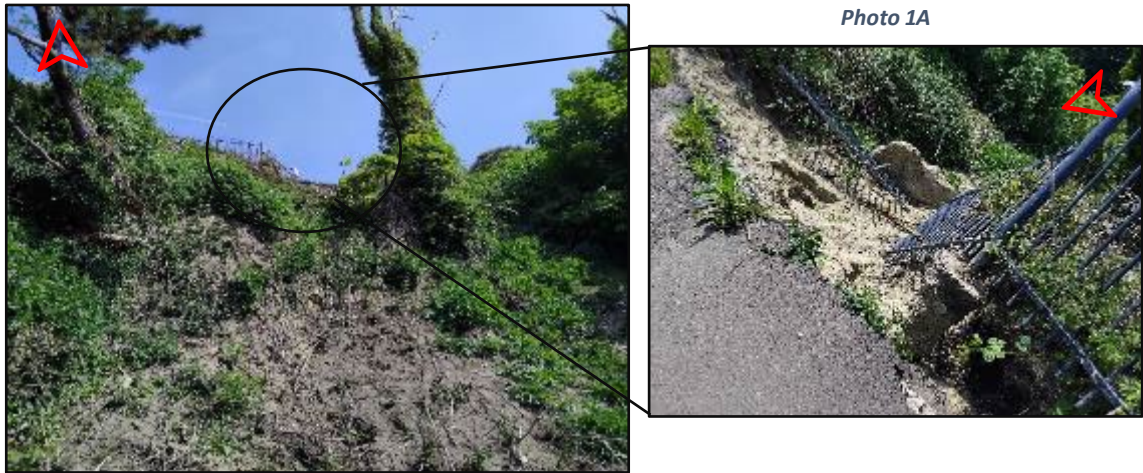
At the crest of the slope at S1, the railings had collapsed and the concrete substructure beneath the asphalt footpath and in which the railings were founded, could also be seen to have collapsed (see Photo 1A). While the asphalt was cracked close to the edge of the footpath, no significant cracks were apparent further away from the edge of the path at S1. The material that was present across the surface of the intermediate footpath appeared to be loose silty sand and this material also appeared to be present beneath

the asphalt path at the top of the slope. A lot of vegetation including roots, rootlets and larger tree roots and branches were noted to be strewn across the intermediate footpath as was some general waste / litter.

*Photo 1/1A - Images taken from the footpaths on the 'West Cliff' between the coastal park and the promenade at the top of the slope / cliff looking at the slip surface.*

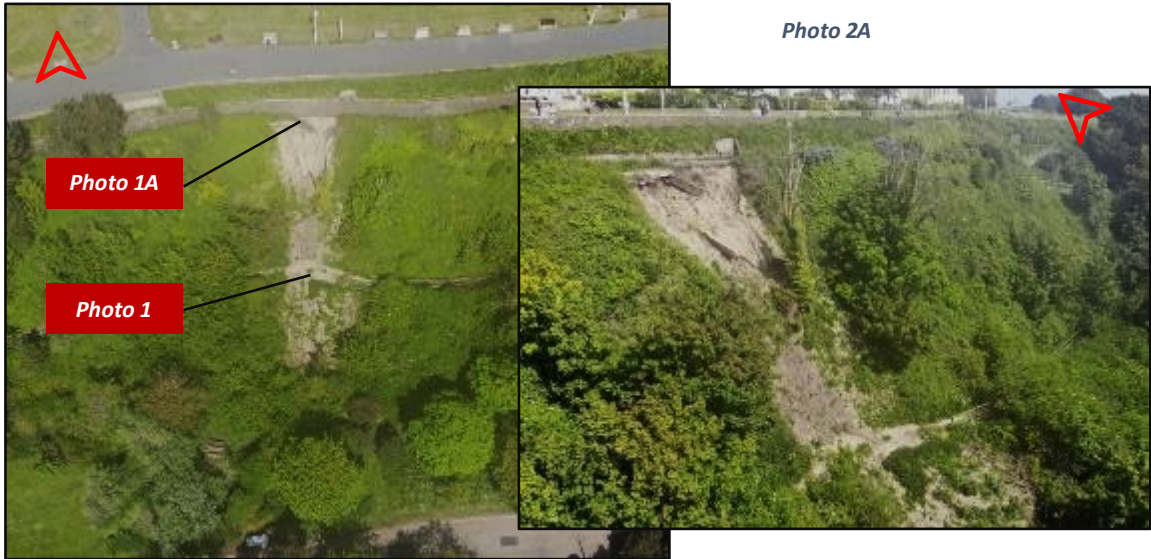
'S1' is the western most landslide / slip that occurred on the part of the slope annotated as 'West Cliff' on the lidar survey. At this location, it was observed that a landslide had occurred from the southern side of the footpath adjacent to the promenade at the top of the slope and material had subsequently slid down to the intermediate path approximately mid-way up the slope between the coastal park / Sandgate Road with loose material from the landslide also noted to have slid further down beyond the intermediate footpath.

*Photo 2/2A - Aerial images showing the extent of the landslide / slip from the footpath below the promenade across the intermediate footpath between the promenade and the coastal path and further south between the intermediate footpath and the coastal park.*

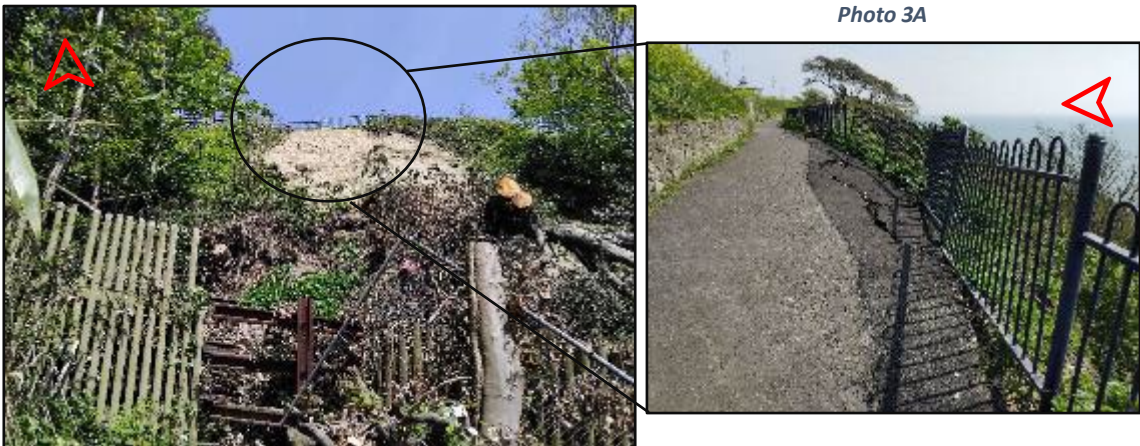
*Photo 3/3A - Images taken from the northern extent of the adventure playground and at the top of the slope showing the extent of the landslide that occurred to the immediate east of 'The Vinery / The Leas Esplanade'. Photo 3A shows the continued and ongoing damage to the recently repaired asphalt path and railings.*

At the top of the slope at this location, the asphalt footpath and railings has been recently repaired following the landslide / slip, however it is understood that shortly after (within a few days) of the asphalt footpath being repaired, cracks in the new asphalt appeared and the level of the asphalt close to the edge of the path dropped and the railings began to lean southwards towards the slope suggesting that the underlying soils at the top of

the slope at S2 remain loose and susceptible to further movement (see Photo 3A). A drainage gully was also noted to be present at the eastern extent of 'The Vinery' structure. This gully appeared to be configured to discharge surface water runoff from 'The Vinery' and adjacent footpath and given that during heavy rain and storm events water would be discharged to a focussed point, such drainage may also contribute to the landslide / slip at S2.

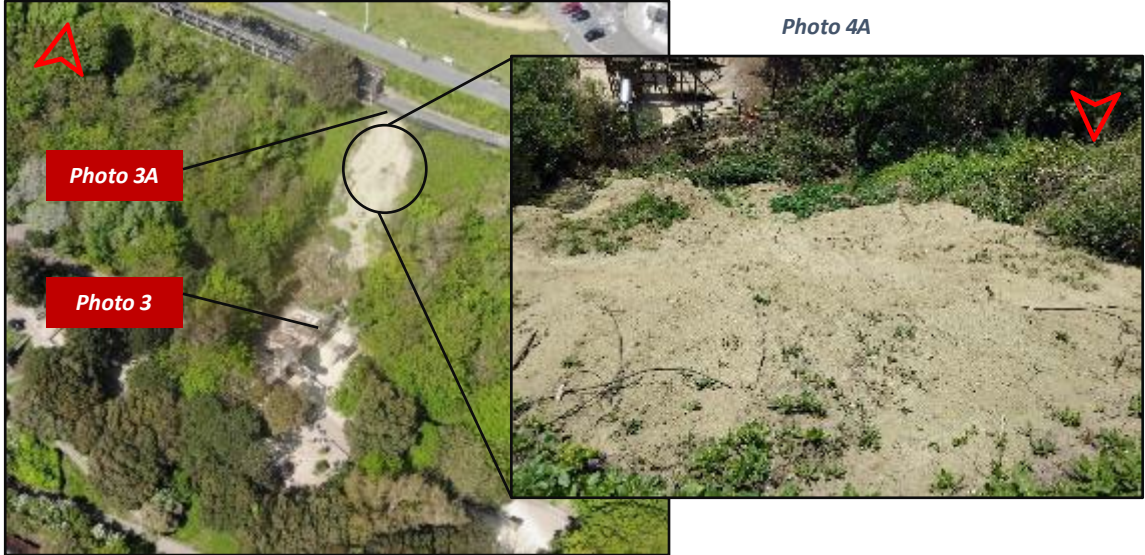
Loose material present across the slip surface was similar to that observed at S1; light beige silty sand, however, at S2 there were seemingly more frequent fragments of sandstone / limestone present both within the loose material and visible on the slip surface of the slope. Many fallen trees, branches and roots were also visible on the slope as were some tree stumps and branches that appear to have been cut / felled following the landslide / slip. At the toe of S2, a retaining type feature was visible, this feature which was constructed from steel pillars extending vertically into the ground and joined by 'I' beams between the pillars was finished with timber slats some of which were seemingly damage / broken / removed by the landslide / slip.

*Photo 4/4A - Aerial image showing the extent of the landslide / slip at S2 between the footpath adjacent to the promenade and the adventure playground with the coastal park. Photo 4A is an image taken from the top of the slope at S2 showing loose material and seemingly competent rock exposures.*

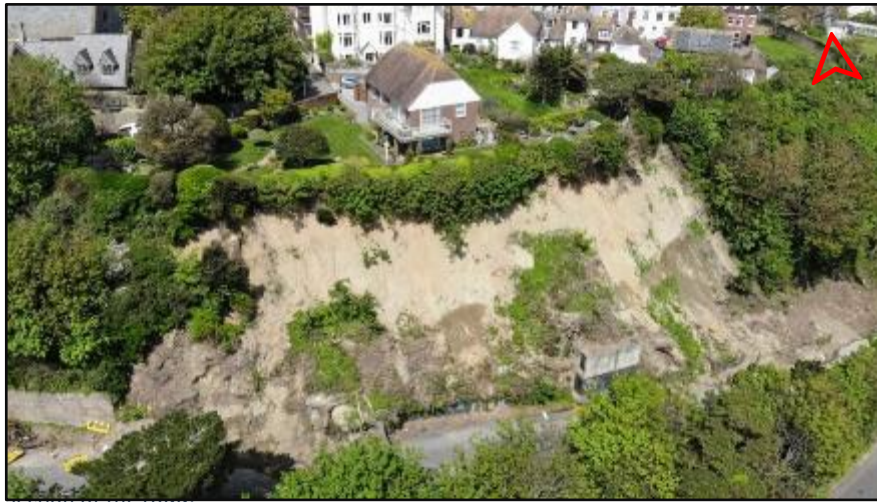
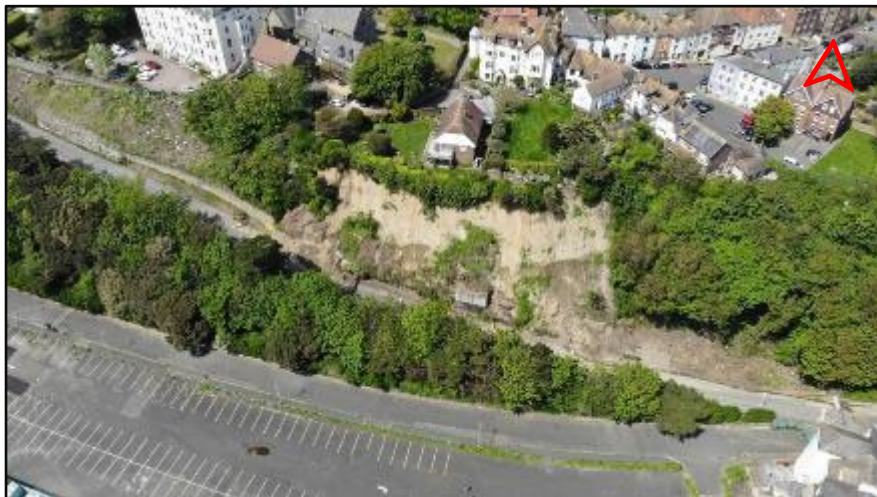
Along the eastern section of Road of Remembrance (to the east of the coastal park) a landslide / slip that is greater in its lateral extend was observed. This landslide / slip occurred from the slope above (north of) the Road of Remembrance. During EPS' inspection, it appeared that loose material that had slid onto the road itself had been removed and cleared however some large collapsed trees remained and were obstructing the road, some of these appeared to have been partly cut and the roots of

*Photo 5 - Aerial image showing the extent of the landslide / slip at S3 along the eastern section of the Road of Remembrance.*

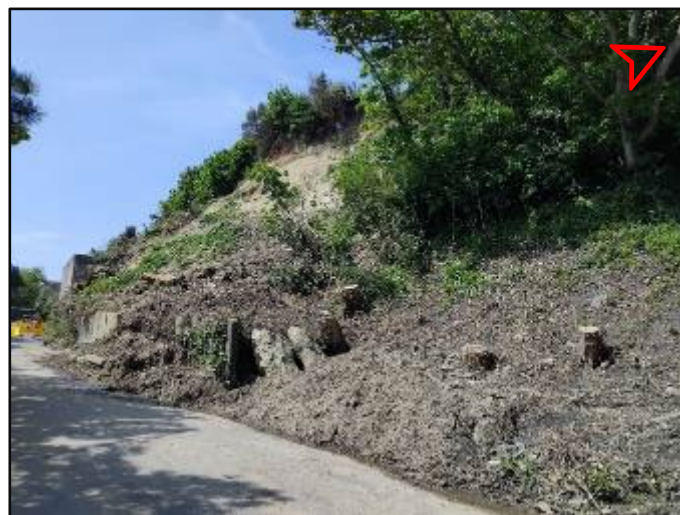
*Photo 7 - Image showing the landslide / slip at the eastern extent of the Road of Remembrance.*

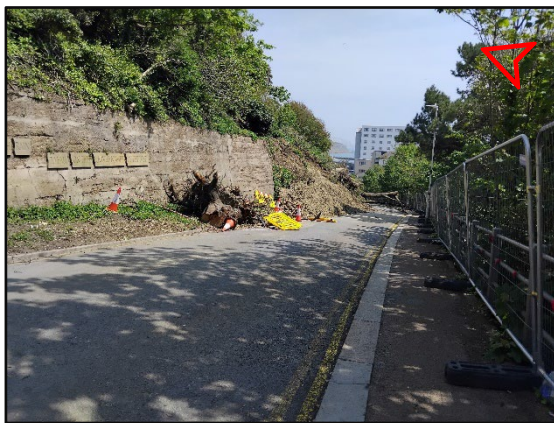
A simple concrete retaining feature spans much of the slope (see Photo 8), with loose soil and dense vegetation having slipped over most of it. In some locations, the concrete retaining wall was not visible due to an abundance of soil and possibly because large trees had damaged the concrete. Additionally, a seemingly disused structure (see Photo 9) is present adjacent to the northern side of the road. This structure is a two-storey concrete building set back into the slope, with former doorways visible on the western side. The visible sections of the structure did not appear to have been damaged by the landslide/slip.

*Photo 8 - Image showing the inclined retaining wall structure and western extent of the landslide / slip along the Road of Remembrance.*

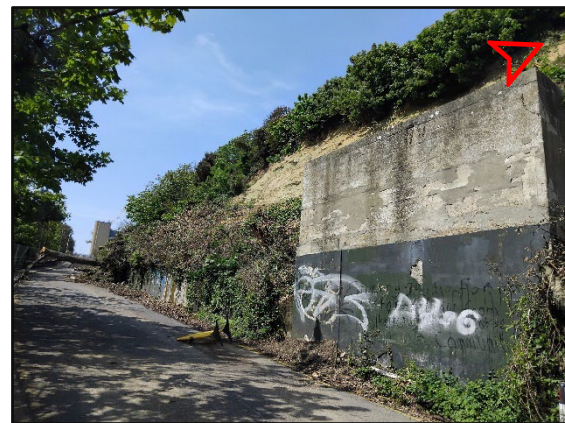
The slip surface at S3 (shown partially in Photo 9) appeared to comprise a combination of loose light brown / beige silty sand and darker brown, possibly slightly clayey and seemingly slightly damp (in some places) topsoil. It is possible that the slightly damp soils are a result of the material that moved during the landslide / slip drying out and it is not considered that damaged drainage was a reason for the damp soil as no evidence of such drainage was apparent (although this cannot be ruled out). Some large cobbles and boulders of sandstone / limestone may have been present on the slip surface and similar fragments of rock could have also slipped from the slope onto the road however given that the road has been cleared prior to EPS' inspection, this cannot be confirmed.

*Photo 9 - Image of the landslide / slip above a small retaining feature / structure on the northern side of the Road of Remembrance and disused unknown structure.*

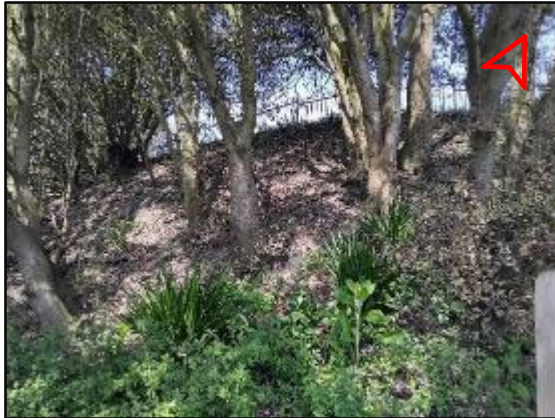
The part of the slope adjacent to the steps extending northwest (southeast from the footpath at the top of the slope) is locality L1. At this location, many exposed small roots and rootlets are present and vegetation is relatively sparse between the small to medium sized deciduous trees with seemingly loose topsoil present between the trees, these observations could be indicators or erosional and weathering processes in this area. The majority of the trees appeared to be slightly leaning southwards in the direction of the falling slope and beyond the area where soil is visible at the surface and not obstructed by low level vegetation.

The steepness of the slope increases as you move up towards the promenade with the calculated slope profile in Figure 3 identifying a maximum angle of approximately 48 degrees in the area of 'loose soils' which could also contribute to instability. Photos 10 and 11 taken from 'L1' are presented below:

*Photo 10 - Image showing the slope at L1 taken from The Metropole Steps*

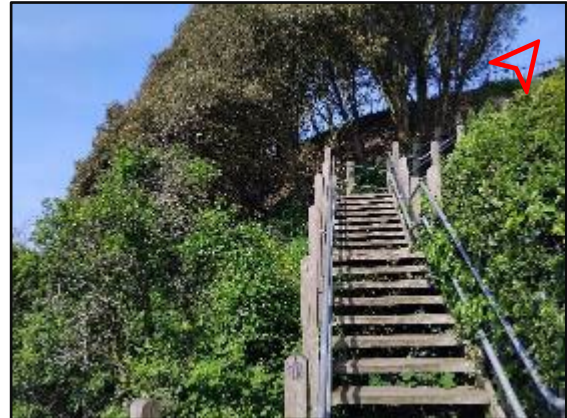
*Photo 11 - Image showing the slope at L1 taken from The Metropole Steps.*

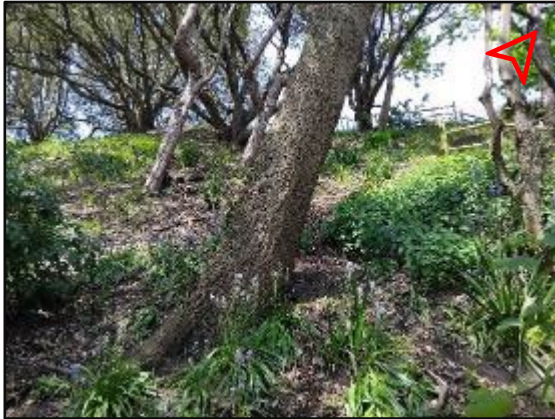
of approx. 43 degrees in the area of 'loose soils' near the footpath which could also contribute to instability. Photos 12 and 13 taken from 'L2' are presented below:

*Photo 12 - Image showing the exposed soil and tree roots at L2*

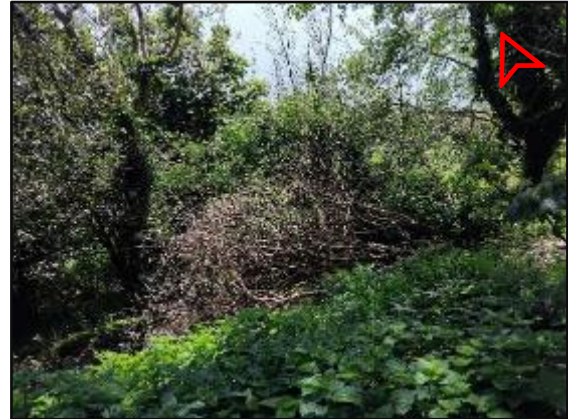
*Photo 13 - Image showing a collapsed tree at L2*

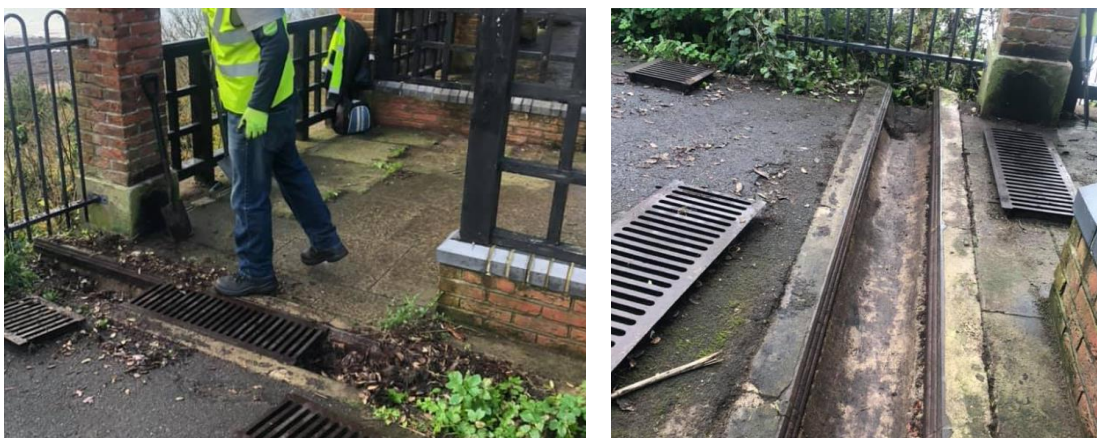
Online photos from various sources show the drainage gully at 'The Vinery'. Photo 1 suggest that the gully directly discharging surface runoff to the cliff. However, note that the landslip did not occur directly under the gully but some metres away from it. Therefore, it may not have contributed to the failure, but it carries a risk to the cliff directly below it.

Photo 1. Photographs showing the same drainage gully at the 'Vinery' before and after cleaning in 2021 (taken from Folkestone Town Sprucer Facebook Page, posted 09/11/2021)

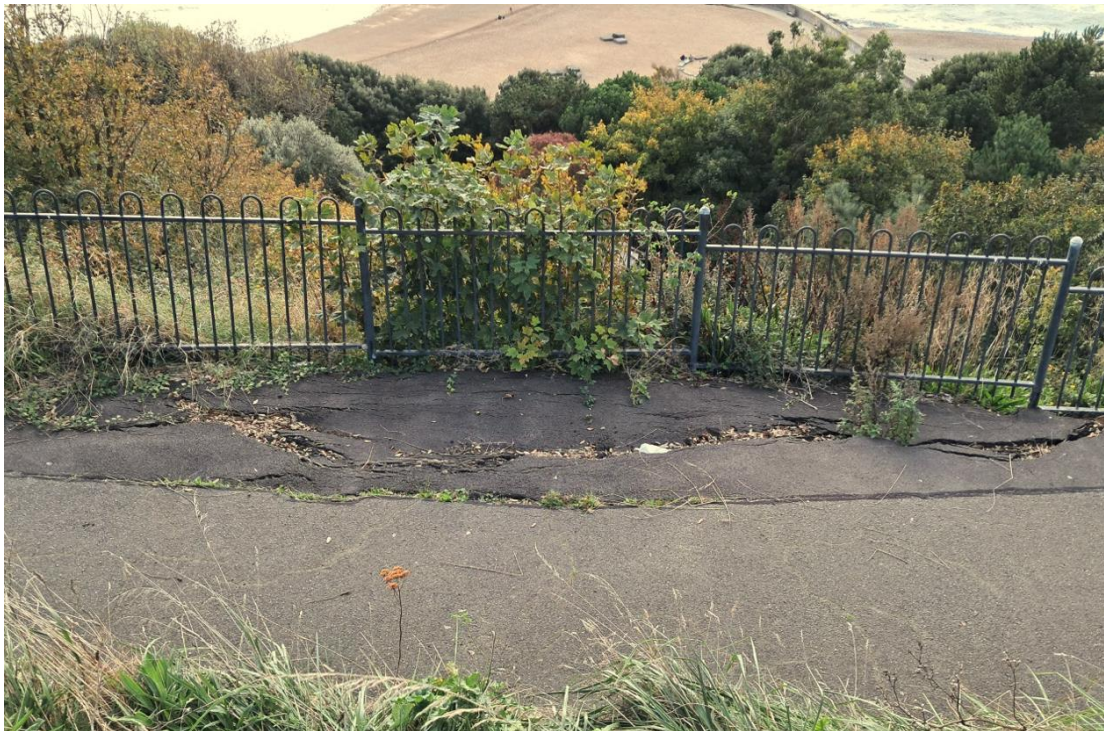
The paved footpath likely contributed to surface water ingress to the slope by directing some surface runoff to the cliff (Photo 2).

Photo 2. New cracks at the crest of the cliff shortly before the landslide. The pavement was repaired when the cracks first appeared (photo taken during our site visit)

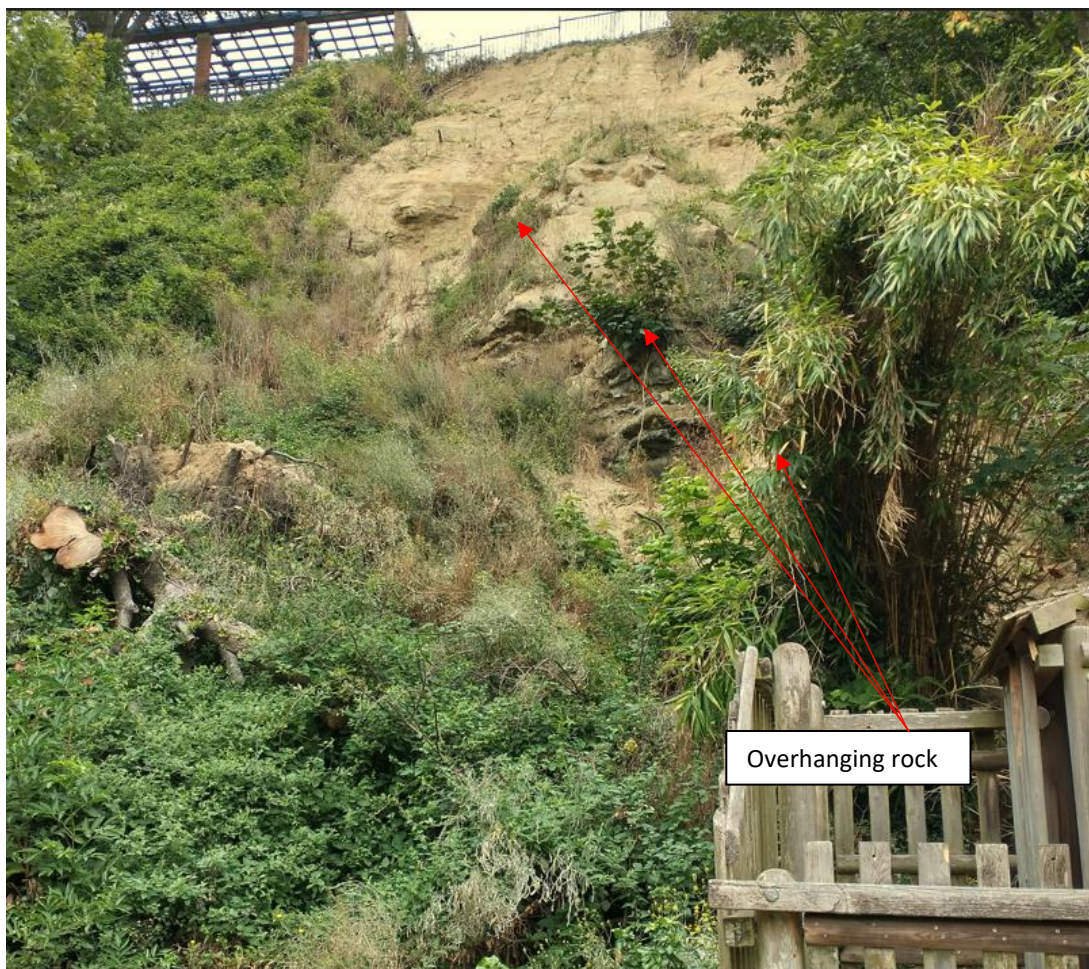
At top of the cliff, within a depth of approximately 2 m below pavement level of the Upper Leas footpath, the cliff is currently at around 70-80 degrees (post failure). Here, there are no sandstone blocks observable within the cliff face, suggesting the sand forming the cliff must be cemented in order to support the steep face angle. However, numerous shallow rain channels/rills are present, suggesting the soil cement is weak and that the material can be easily eroded. Above this zone, large tension crack can be seen along the pavement.

Photo 3. Photograph showing landslip, taken from toe of the slope

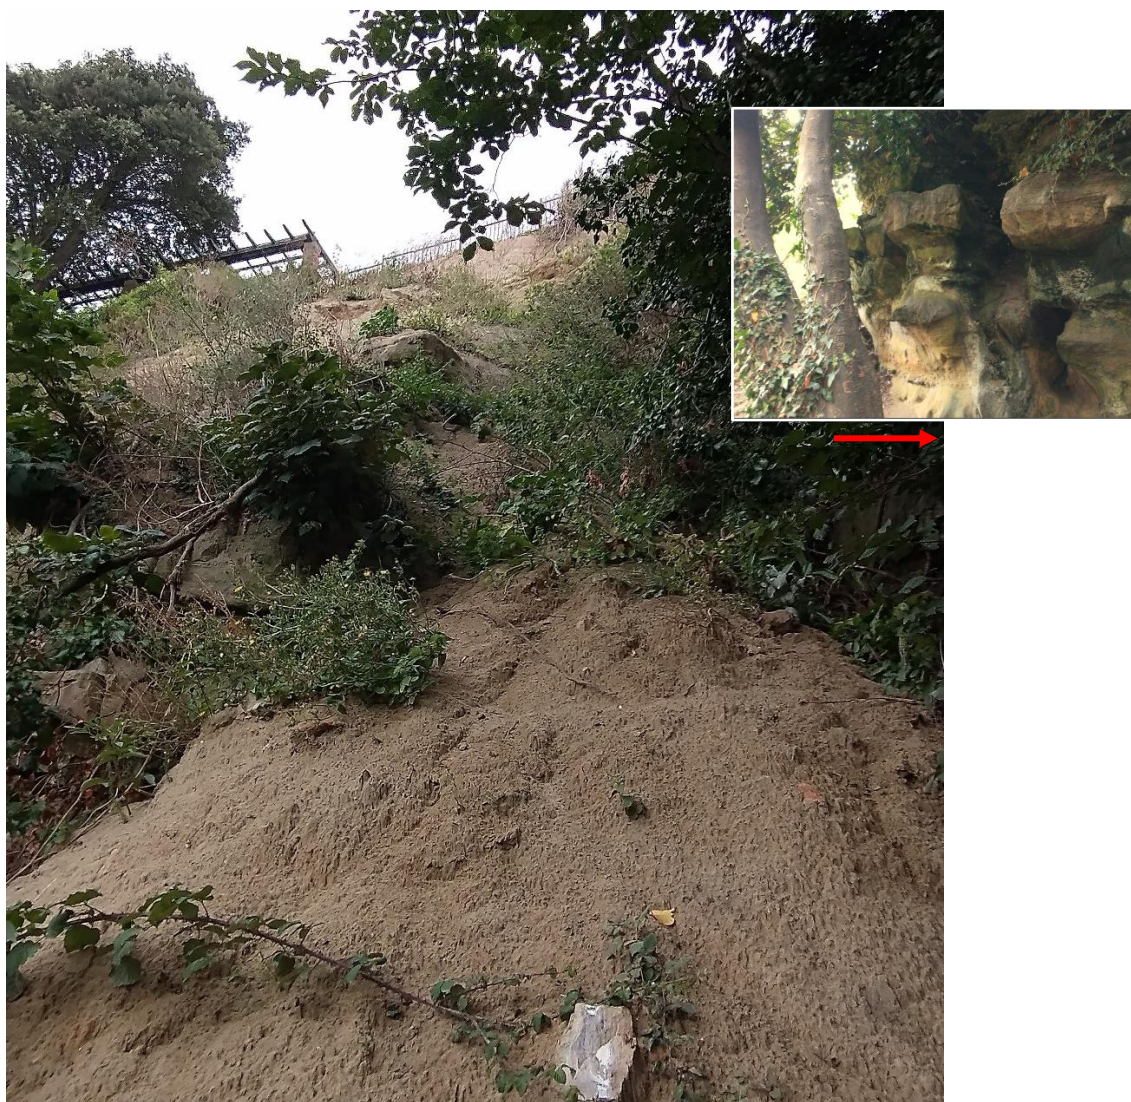
apparent, considering the slipped material and the adjacent slope (outside the slip area), that the slip failure is a translational slip where an approximately 1m thick weathered material from the upper and mid-slope has displaced over the lower slope. Softening of the slope due to water ingress as a result of very wet 2024 autumn-winter period is considered one of the reasons of the slope, especially at the location shown in Photo 4. It is likely that the weight of trees possibly overcame the strength of the roots which could be a contributing factor to the slip. Hence, it is likely that there is an increased level of risk at the adjacent slopes with trees.

Photo 4. Slipped sandy material, with chert cobble and sandstone bands above. The window shows exposed sandstone blocks at the east (right) of this zone

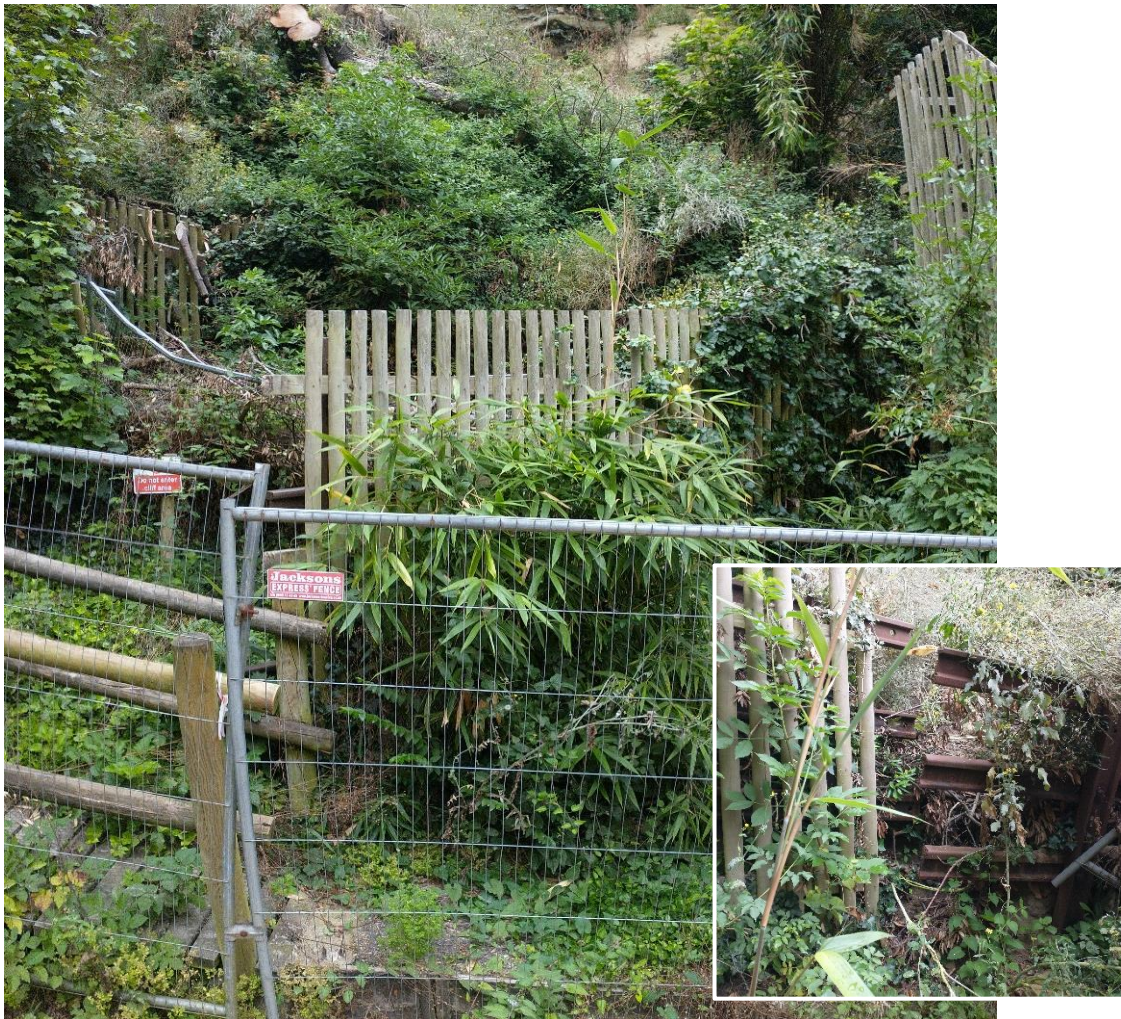
Close to the base of the slope behind railway sleeper, there is a universal column (UC) pillar frame connected laterally by the UCs/I-beams. Wooden facing/cladding (timber slats) was attached to this frame, possibly to hide it from view. This cladding was locally damaged and broken due to slip. At the location of the slip, the frame locally moved down the slope (Photo 5). At the toe, UC column appears almost vertical, suggesting shallower footing (not exposed). Spacing between UC columns is circa 1.45 m c/c, with 5° inclination downward towards east. Steel work is rusty outside otherwise in good condition.

Photo 5. UC column fence with attached timber cladding moved due to slop. Small window shows sheared UC column pillar frame

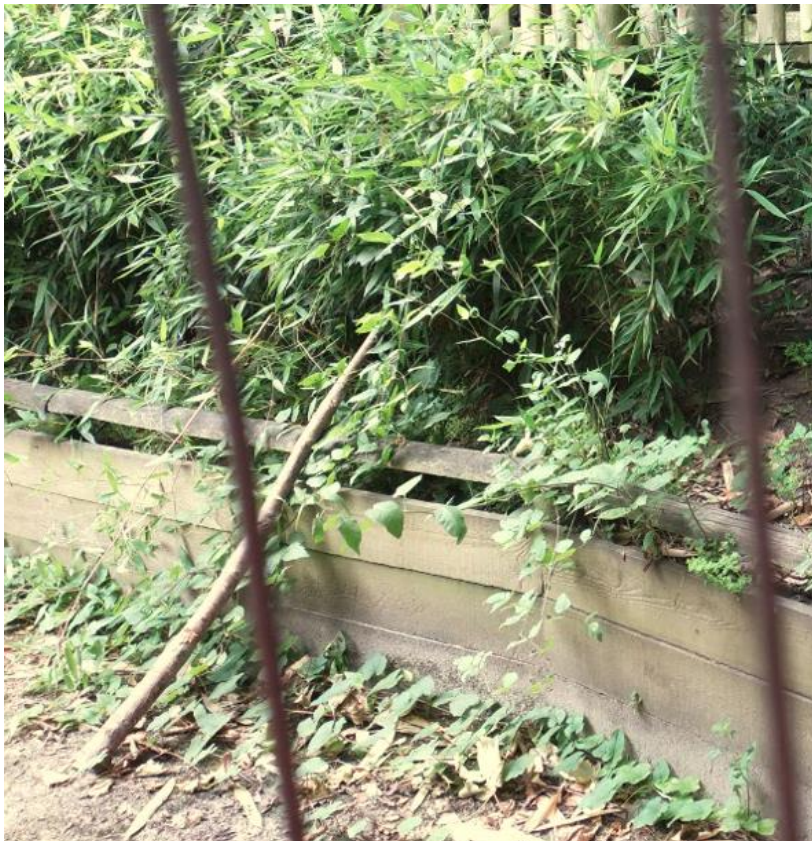
At the toe of the cliff there is a timber retaining wall (approximately 0.5 m high) hiding the toe of the slope (Photo 6). A concrete footpath is between the retaining wall and the playground. It looked stable and without displacements.

Photo 6. Timber beams form the boundary of the cliff

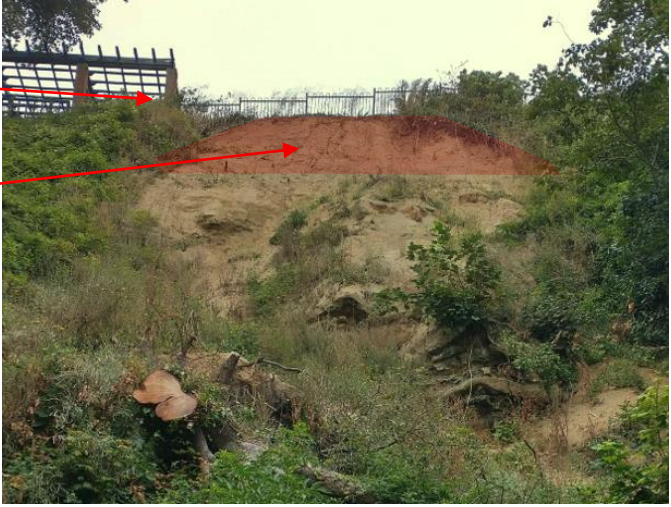
<p><b>Zone of interest A:</b></p> <ol style="list-style-type: none"> <li>1. Existing footpath (Maderia Walk) at and The Vinery structure.</li> <li>2. Exposed cliff with steep slope angles at top 2-3m.</li> <li>3. Similar slope angles at each side of the failure where the cliff is still stable.</li> </ol> <p><b>Risks:</b></p> <p>This very steep section of the cliff has a high risk of failure.</p>

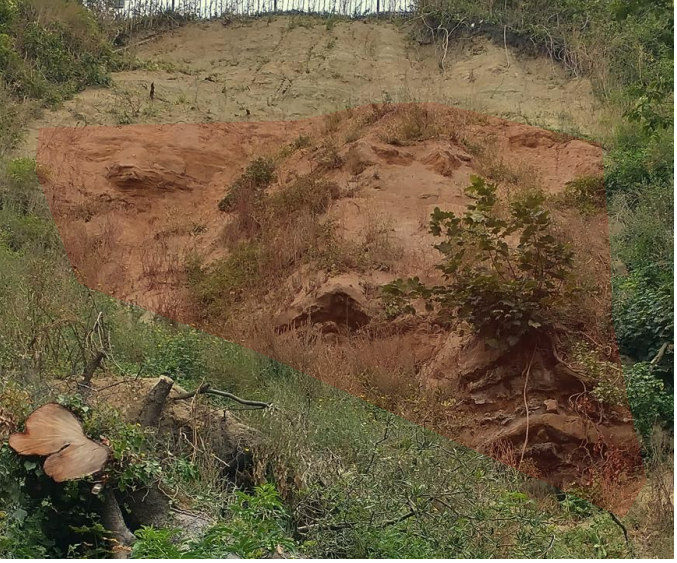
<p><b>Zone of interest B:</b></p> <ol style="list-style-type: none"><li>4. Blocky sandstone visible below this area.</li><li>5. Overhanging rock.</li><li>6. Intermittent weathered zones containing sand</li></ol> <p><b>Risks:</b></p> <p>Rock fall</p>

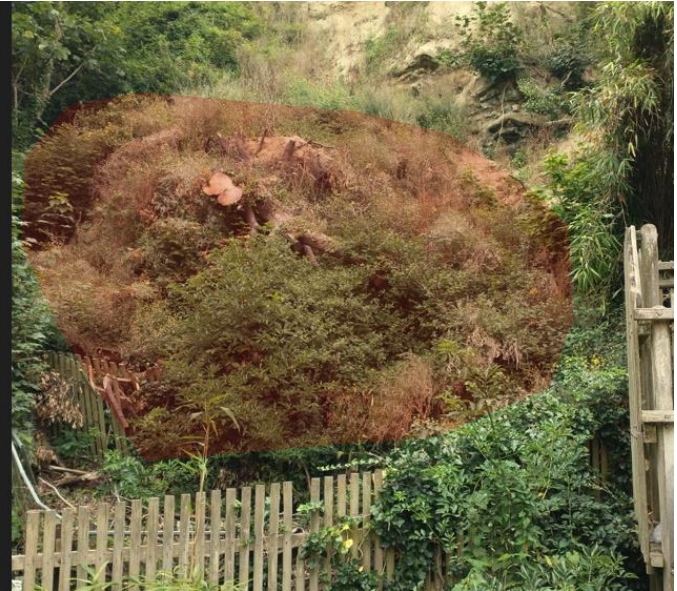
<p><b>Zone of interest C:</b></p> <ol style="list-style-type: none"><li>7. Landslide debris</li><li>8. Possible Folkestone / Sandgate Formation boundary</li></ol> <p><b>Risks:</b></p> <p>Condition of slope and extent of slip unknown.</p> <p>Removal of landslip material will be exposed steeper and de-vegetated slope.</p>

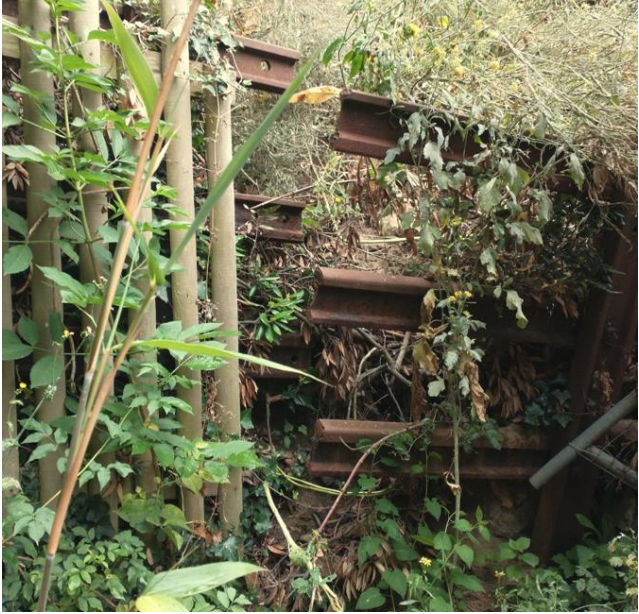
<p><b>Zone of interest D:</b></p> <p>9. Existing failed steel pillar frame and timber fence</p> <p><b>Risks:</b></p> <p>Presence of fence with unknown founding depth retaining landslip material which may result in local instability during debris removal works</p>

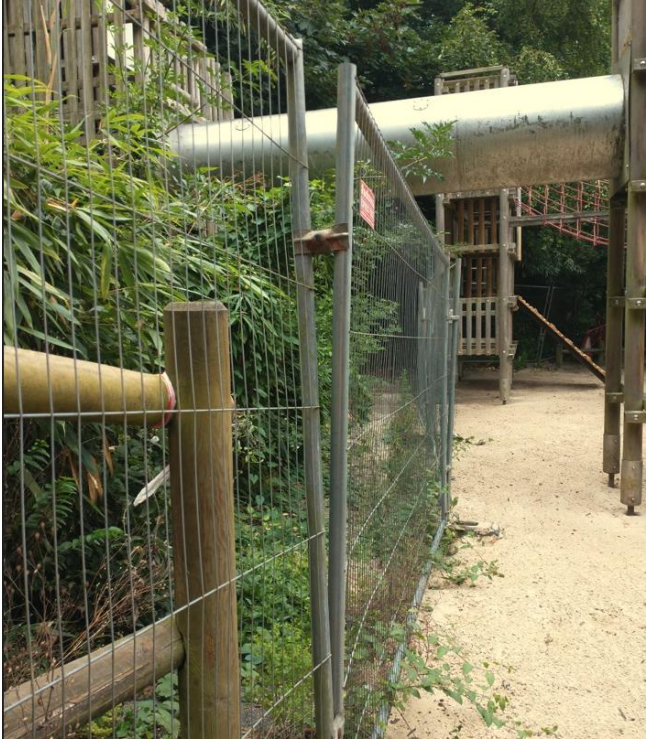
<p><b>Zone of interest E:</b></p> <p>10. Closeness of the cliff to the playground.</p> <p>11. Some playground equipment located on the cliff near the toe</p> <p><b>Risks:</b></p> <p>Likely metastable steep cliff (particularly the very steep zone at the top) which already experienced landslide.</p> <p>Playground structure founded on the slope which is affected by mitigation works</p>
