Report Number **C/25/01**

To: Cabinet
Date: 21 May 2025
Status: Key Decision
Responsible Officer: Aarron McKinney – Engineering & Buildings Manager
Andy Blaszkowicz – Director, Housing & Operations
Cabinet Member: Councillor McConville, Cabinet Member for Assets and Local Government Reorganisation

SUBJECT: Remediation of the Landslides at The Leas, Folkestone

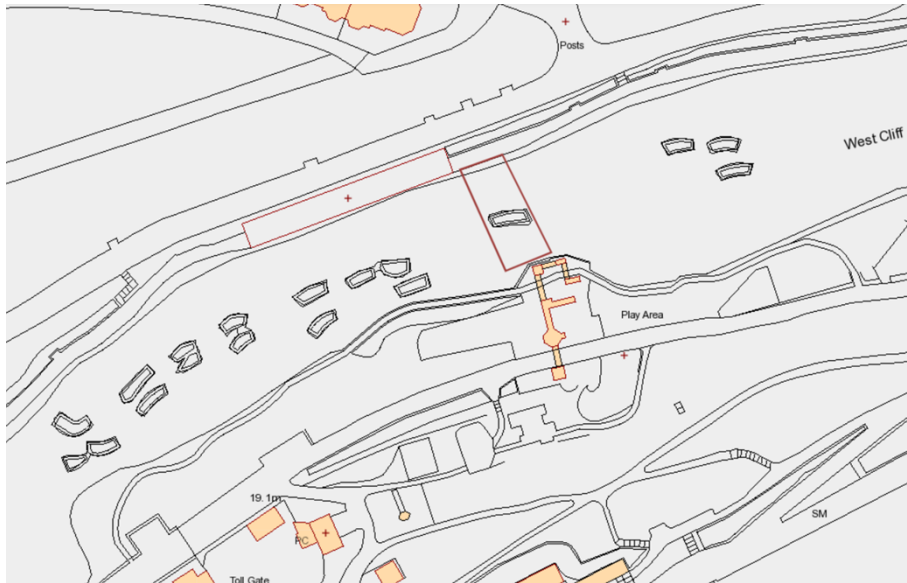
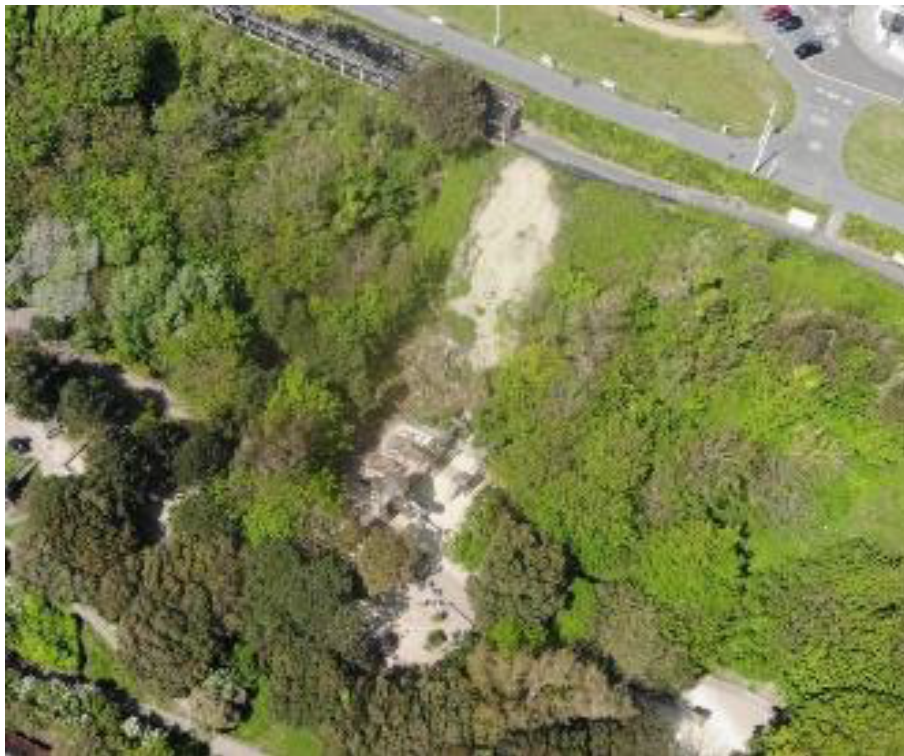
Coastal Park Play Area February 2024 – Vinery

- 1.2 The second landslide occurred to the side of The Vinery directly above the cliffside towers of the Coastal Park play area in February 2024. Following a sustained period of heavy rainfall and during a particularly heavy windstorm the mature tree at the top of the cliff destabilised and the surrounding cliff face gave way causing the landslide to occur. In this instance early indicators were found in the tarmac footpath in the days prior to the slip of parallel running cracks enabling Heras fencing to be erected restricting access to the top and bottom of the cliff. Fortunately, when the original play area was built a king post steel RSJ boundary wall was installed which caught the majority of the slipped material behind preventing damage to the structures beneath.

- 3.2 The steep cliff from approximately the middle of the cliff to the crest comprising poorly cemented sandstone (Zone A) is currently exposed to weathering. Further erosion would result in further collapse of the footpath above. As a result the sections need to be reinforced. Due to the site constraints the most feasible strengthening option is to use high-strength steel mesh and soil nails together with steel plates to prevent a wedge failure.

- 3.3 The second section (zone B) consisting of overhanging rock and intermittent weathered zones can be protected with a 'containment' system. The planned solution is to use a draped netting to reduce the energy of fast-moving landslides. Open ended netting allows for ongoing maintenance to collect and remove landslip materials or rock in case of a landslide. This system can be adapted and extended to Zone C if appropriate once the landslip debris has been removed.

- 3.4 At the toe of the cliff the steel pillar wall which has failed following the landslip and the timber fence will be removed along with the debris without disturbing the underlying slope.

- 3.5 To provide further protection at the base of the cliff Zone E an additional 2m high king post retaining wall will be installed to prevent any landslip material within the containment system from reaching the play area and to allow a clear space behind (where the towers sit) for the collection and clearing of materials in the future.

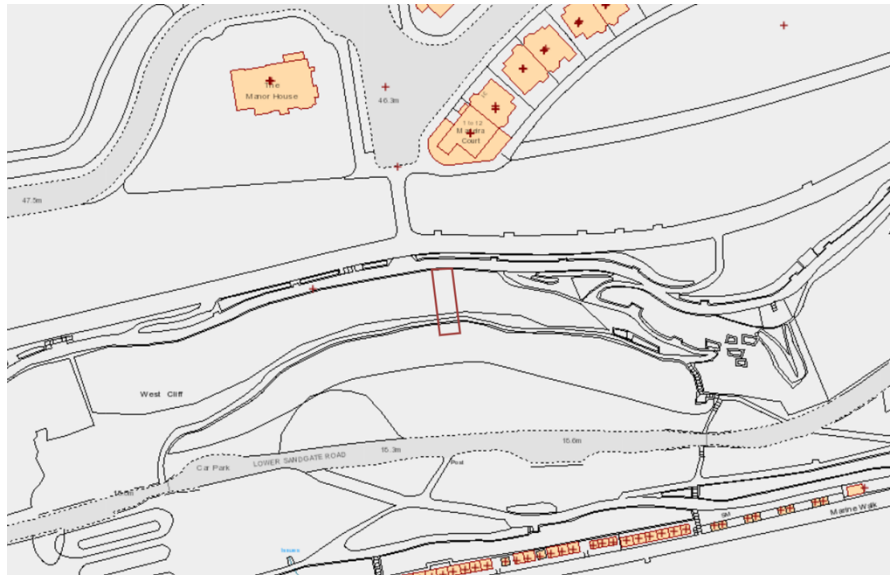
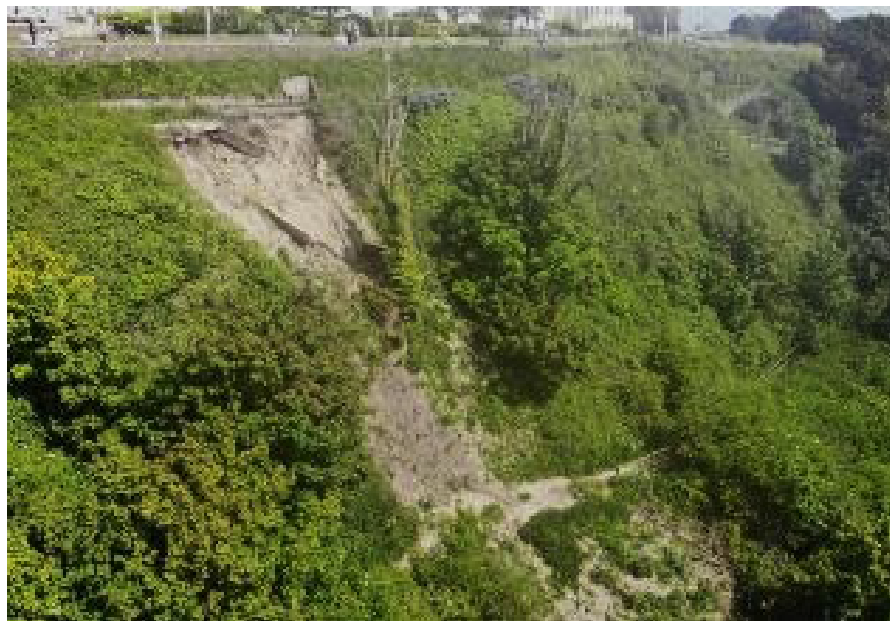
Cow Path – November 2023

- 1.1 The first landslide occurred above the Cow Path in November 2023, following a significant rainstorm. The landslide caused the concrete path edging and approximately 1m depth of loose sand particles and sandstone to slip down the frontage. This caused significant damage to the vegetation below the intermediate footpath (Cow Path) and undermined the Madeira Walk footpath at the summit.

- 1.4 The landslide above the cow path whilst of the same formation presents different challenges in that the material primarily consists of fine sands, has restricted access from below due to the mature trees and will likely require a different remediation methodology.

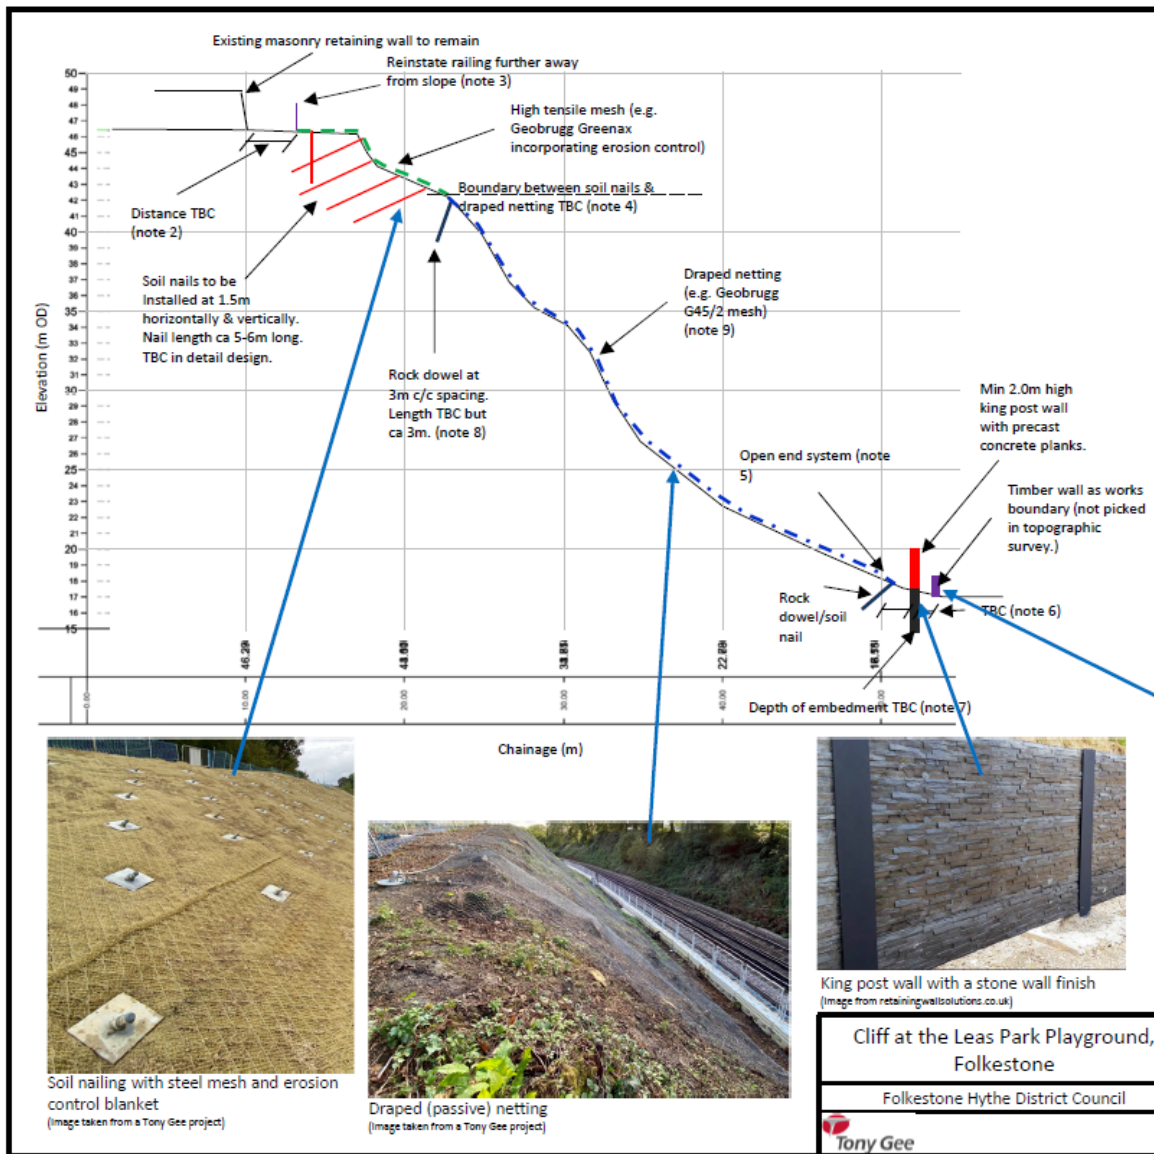
Proposed remediation methodology

Zone A – summit of the cliff, supporting the Madeira Walk footpath and Vinery structure. An exposed cliff with steep slope angles for 2-3m. With similar angles to either side of the failure where the cliff is still stable. (suggesting a need to expand the planned works 5m either side). This is a very steep section at a high risk of failure.

Zone B – below the summit consists of layers of overhanging blocky sandstone with intermittent weathered zones containing sand. This zone presents as a risk of rockfall.

Zone C – The toe of the cliff consists of landslide debris and is possibly the Folkestone / Sandgate formation boundary. Condition of the slope and extent of slip unknown due to the debris. Through the removal of this material the cliff will be steeper and de-vegetated.

Zone D – Existing failed steel pillar frame and timber fence retaining landslip materials. The foundation details of this structure are not known and may destabilise during debris removal works.

Zone E – Closeness of the cliff to the playground. Some playground equipment (towers) located near the cliff toe. This presents a risk due to the potential instability of the cliff and high-risk section in Zone A. This will be
