Folkestone and Hythe District Council

Former Gasworks, Ship Street Development

Contaminated land evaluation in support of the planning application

Issue | 16 June 2025

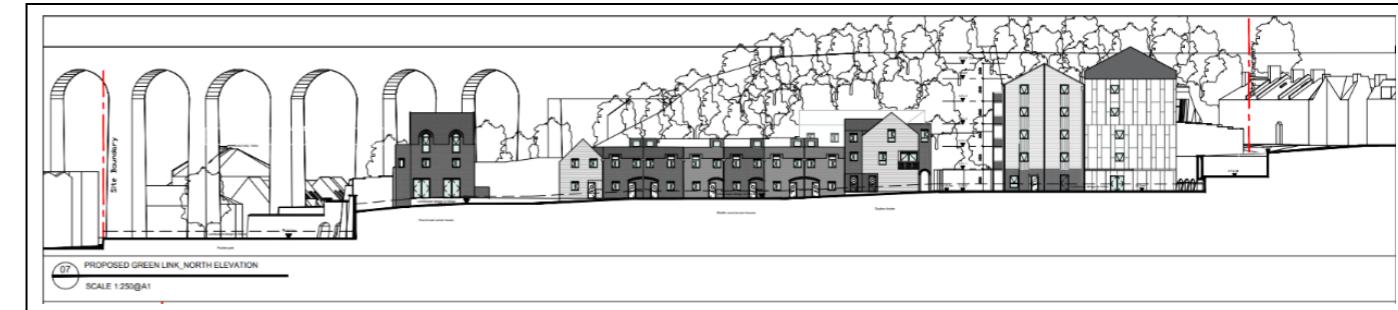
Figure 3 Proposed masterplan

The development includes a mix of apartments and terraced housing with private gardens and will be split on two levels. The foundations are likely to include shallow pad or strip foundations for the terraced housing and pile foundations for the apartment blocks. The proposed development does not include any buildings with basements.

The current elevation varies across the site and the previous remediation (discussed in Section 3.6) resulted in the site being left at 0.6m below the original ground level. To create a level development platform suitable for the proposed development, earthworks will be required.

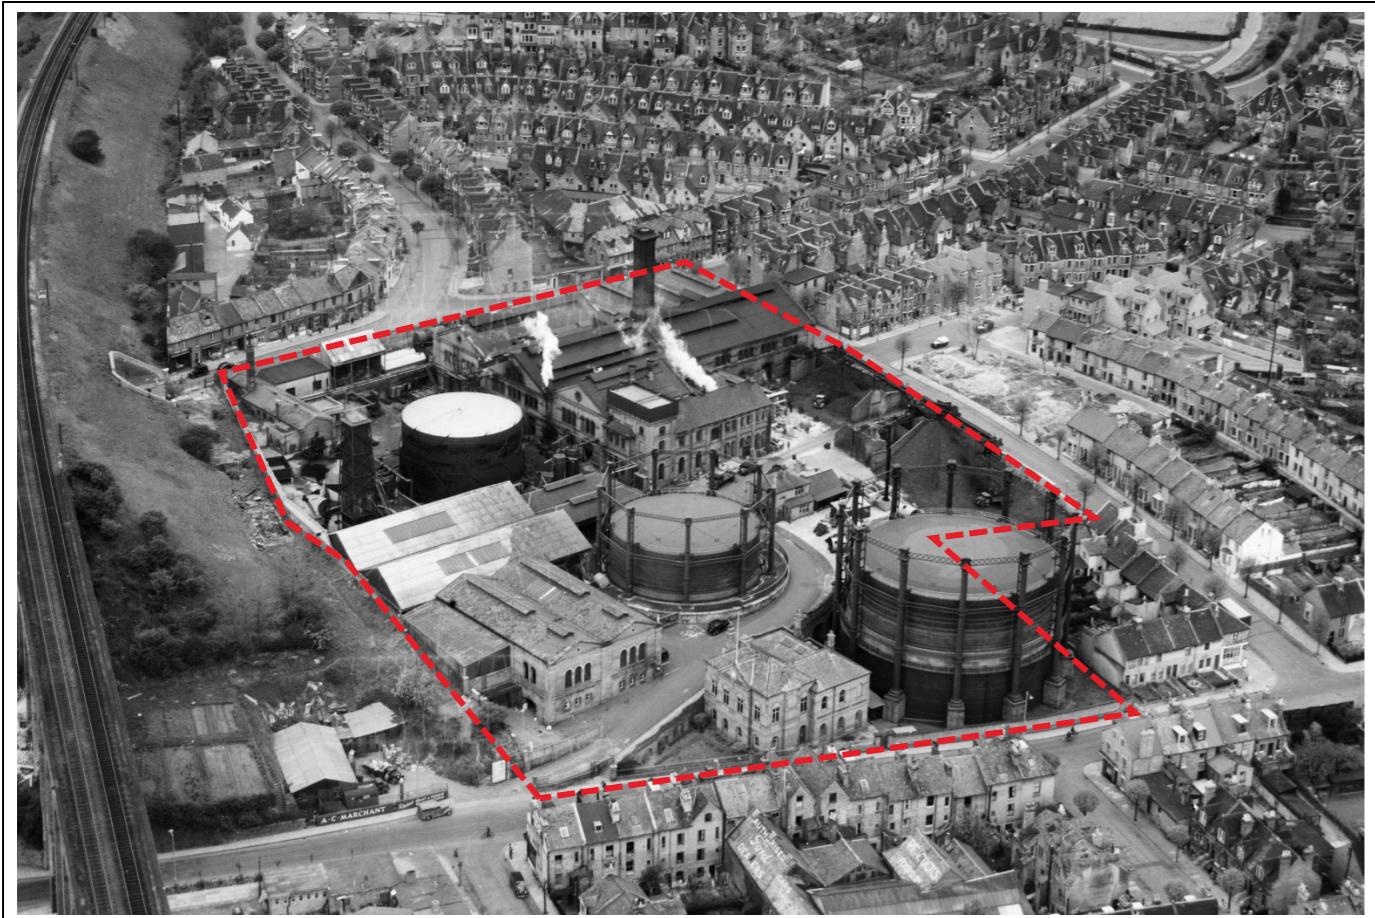
Figure 6 1949 aerial imagery EAW023048 © Historic England Archive

Figure 6 on the next page shows the gasworks, photographed from the air in 1949; the layout appears to be same as in 1898. The site remained in this configuration with minor additions of buildings, tanks and small-scale structures until 1956. In 1949, the site company was dissolved, and vested in South Eastern Gas Board under the Gas Act 1948 [18]. The South Eastern Gas Board was nationalised and became part of the Dover Group of the Kent County Division of SEGB. The gasworks was closed in 1959 and replaced by a site in Coombe Valley Road, Dover [17].

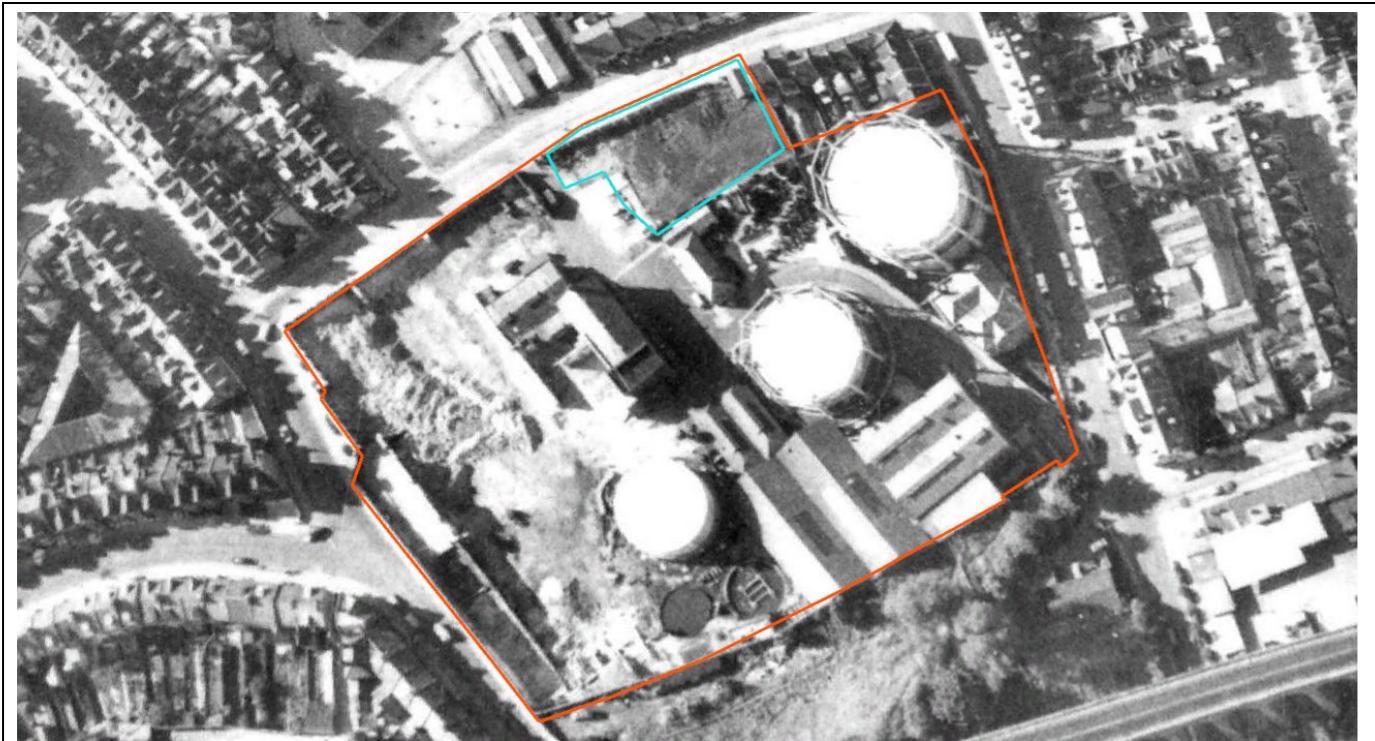
Figure 7 Extract from Google Earth 1960 aerial photography

A large proportion of the site was demolished between 1960 and 1964, with the gasholders remaining for storage purposes until 2001 when gasholders No.3 and No. 2, which had below ground tanks, were dismantled and backfilled. Based on the information provided in the 2007 Environmental Improvement Strategy [7] the bases of Gasholder No. 2 and No.3 were approximately 7m below the original ground level and remain in situ. Gasholder No.1 was also dismantled in 2001 but comprised an above ground structure with a concrete slab at ground level [19]. The internal retaining walls, part of a tank structure and red brick perimeter walls are the only remaining structures from the gasworks onsite.

Figure 7 is an aerial photograph from 1960 which shows the partial demolition of the site.

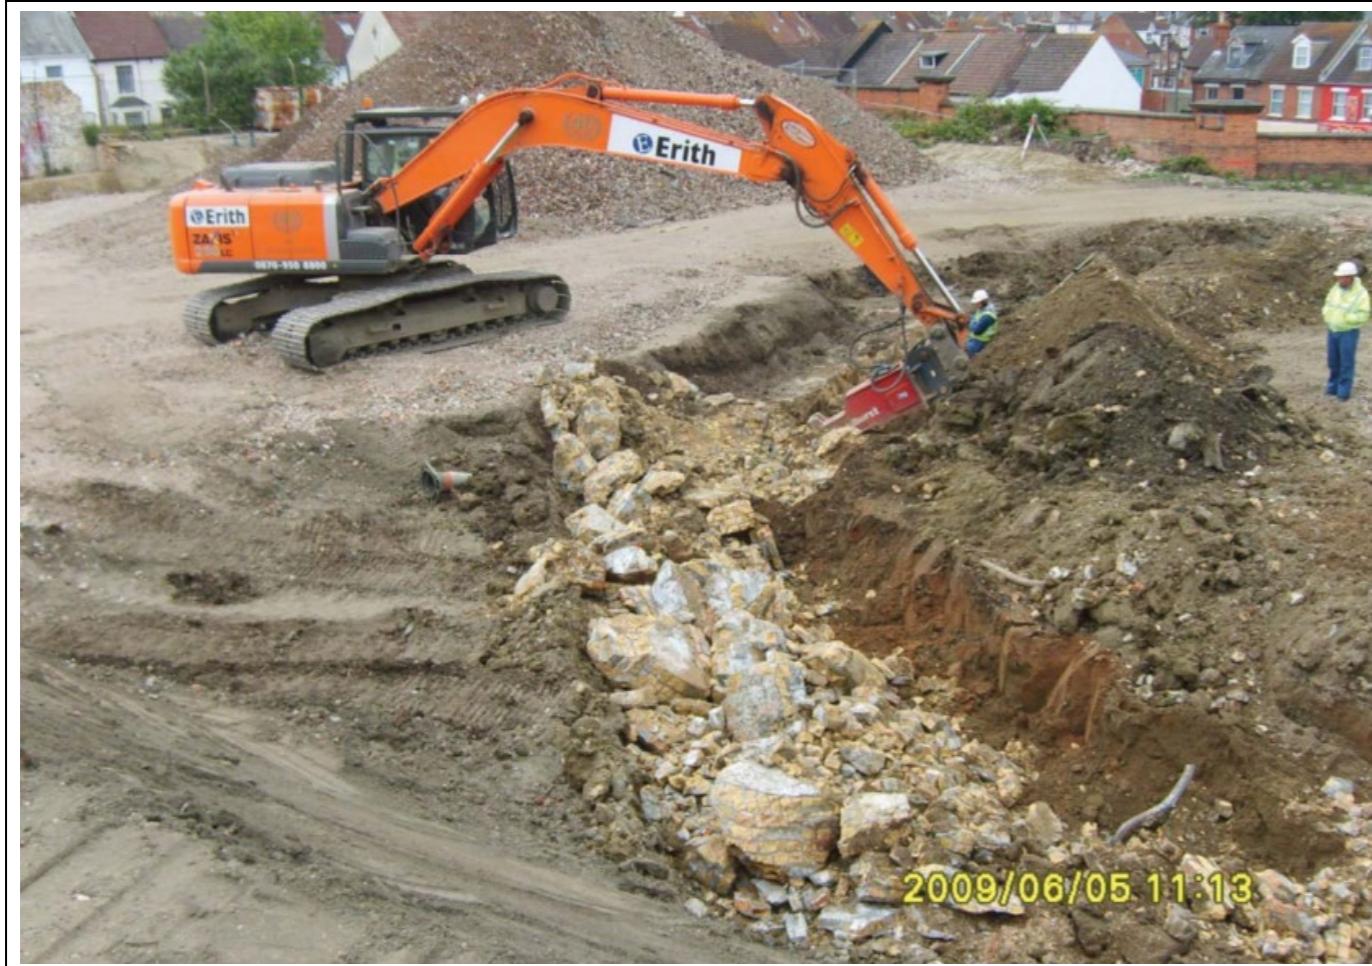
Figure 10 Partial demolition of gasholder walls (extracted from Mouchel Parkman factual report [8])

During the excavations, residual foundations and substructures were encountered and removed where possible. The two underground gasholder structures were broken down to 2m below the original ground level (now at 1.4m bgl current ground level) with the remaining 5m of wall structure left insitu as shown in Figure 10.

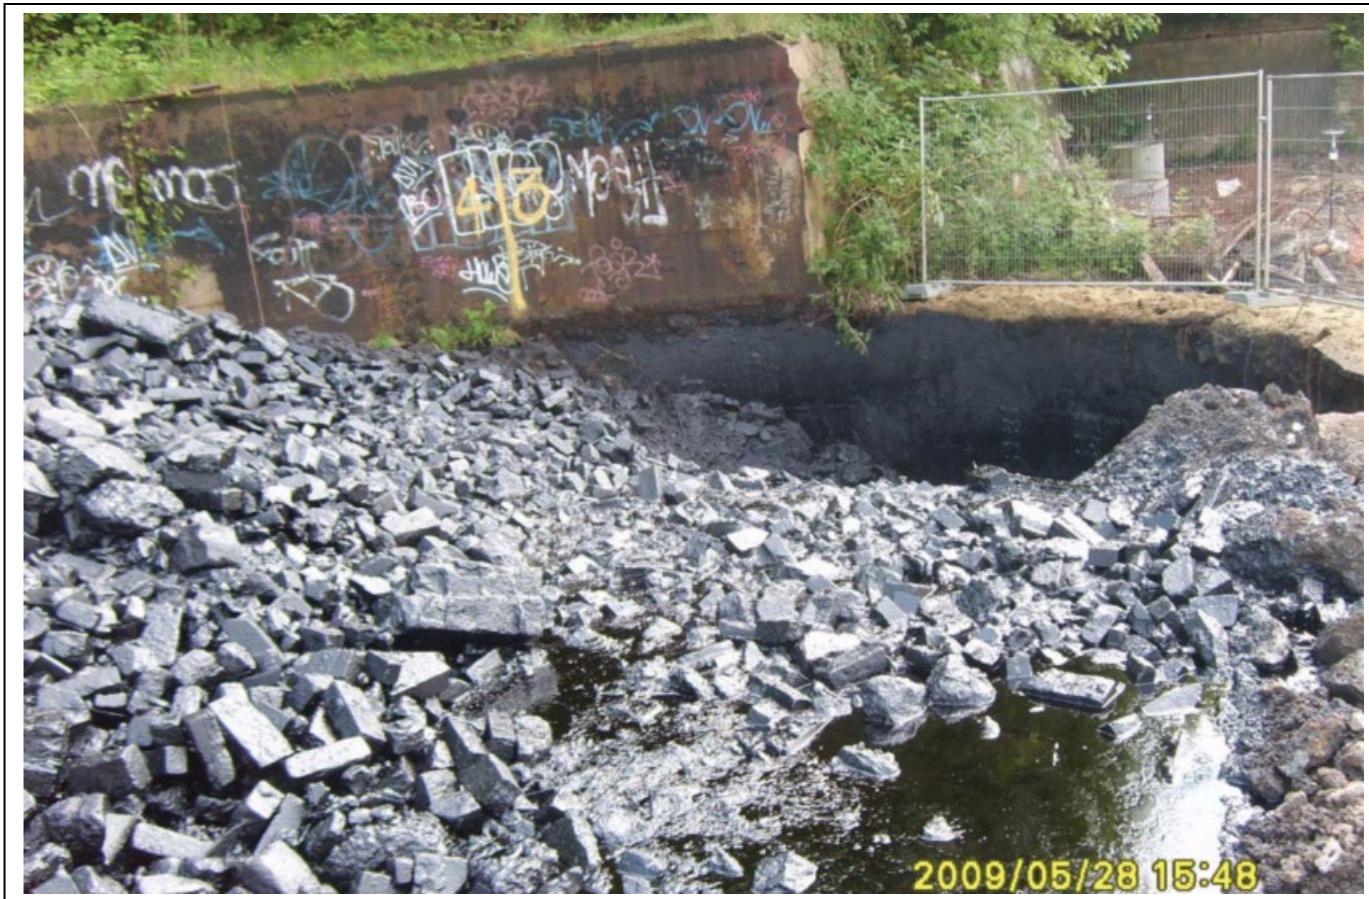
Figure 11 Excavation of contaminated material from a tank during the remediation (extracted from Mouchel Parkman factual report [8])

Other tanks that were identified during the works were emptied and, if possible, excavated along with any contaminated surrounding materials as shown in Figure 11. The Mouchel verification report [8], identifies the residual structures that were left in insitu and a summary is provided on Drawing 1. This includes a reinforced concrete tank, brickwork, concrete slabs and foundations and a cast iron segmental tank (believed to be part of the retaining structure in the south). Pipe work and tanks found contaminated with tars were disposed of to a suitable licenced facility.

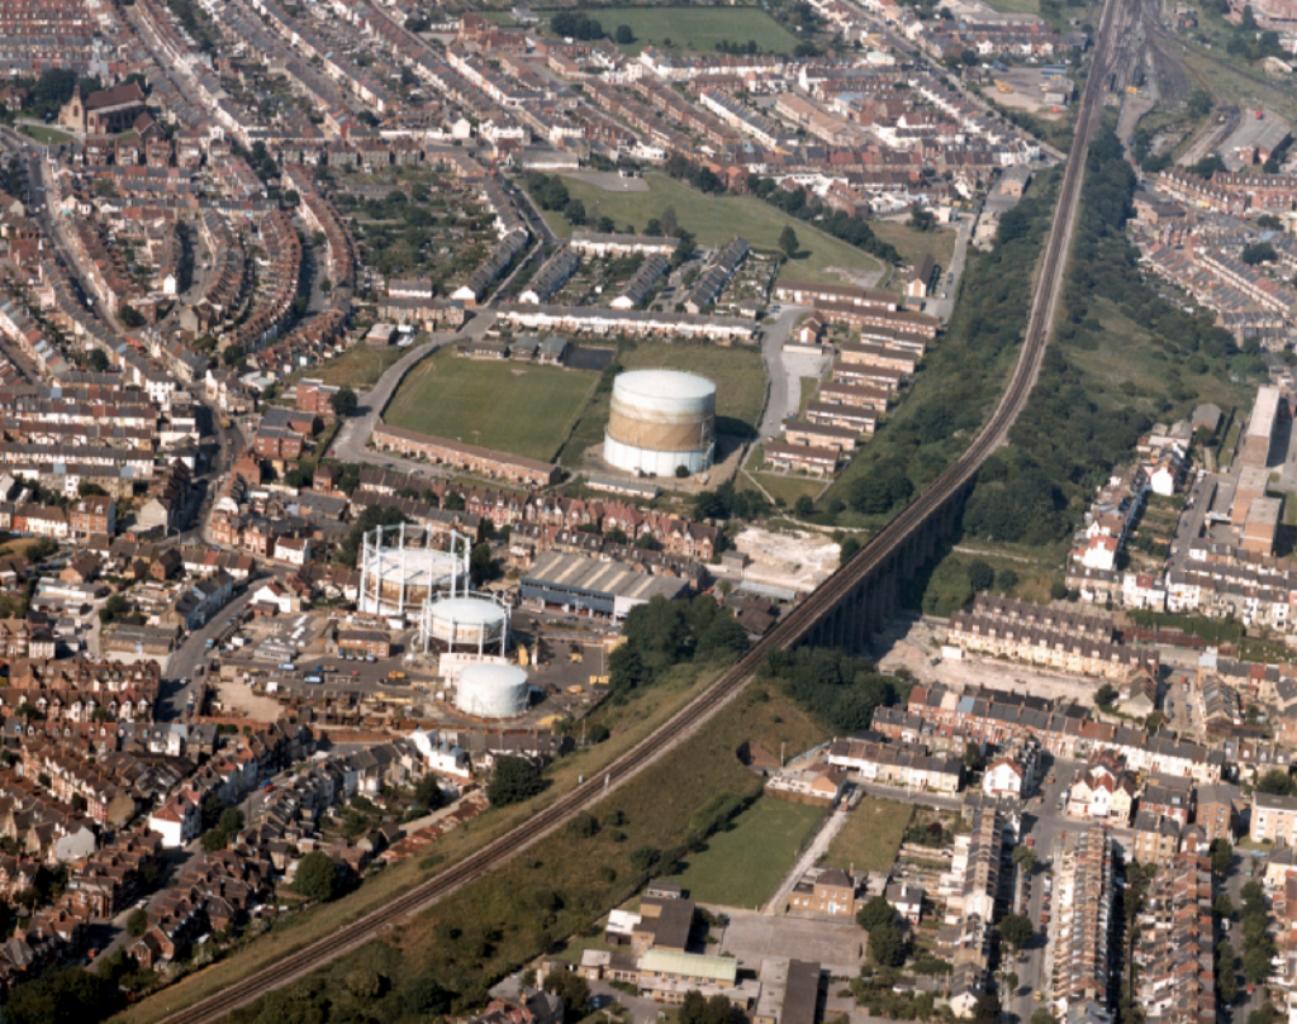
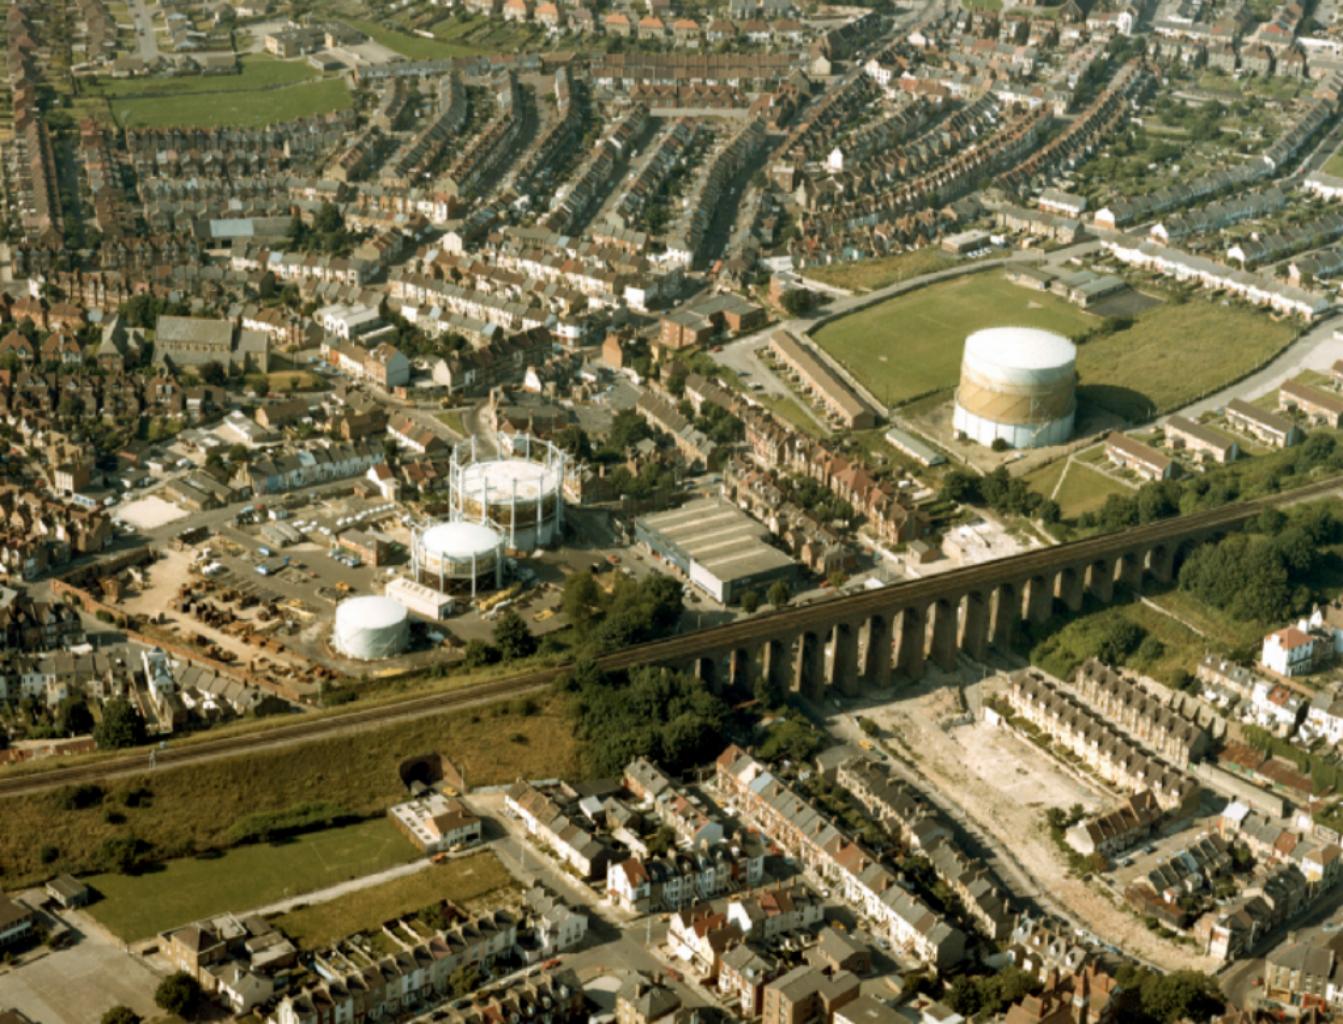
THE FOLKESTONE GAS AND COKE COMPANY
PLAN OF WORKS, SHIP STREET, FOLKESTONE.

Folkestone Gas and Coke Company (1842 - 1949)

The original Folkstone Gas & Coke Company was established in 1842 and incorporated by special AoP in 1865. The works were situated on Ship St and the lack of railway sidings into the site meant that coal was unloaded at Shorncliffe station and transported to the works by lorry. In 1916 the Hythe and Sandgate Gas Company was amalgamated with Folkstone and in 1933 the Folkstone GCC came under the control of the SE Gas Corporation. On nationalisation in 1949, the undertaking, along with New Romney and Lydd, became part of the Dover Group of the Kent County Division of SEGB
