**CLIENT**  
 Folkestone & Hythe District Council

**JOB TITLE**  
 Leas Cliff,  
 Folkestone,  
 Kent.

This report presents the findings of a visual slope stability assessment which was carried out to assess potential reasons for slope failure and assess the possibility of future landslips.

Document no: A124037-TGEE-GEN-XX-RP-C-0001

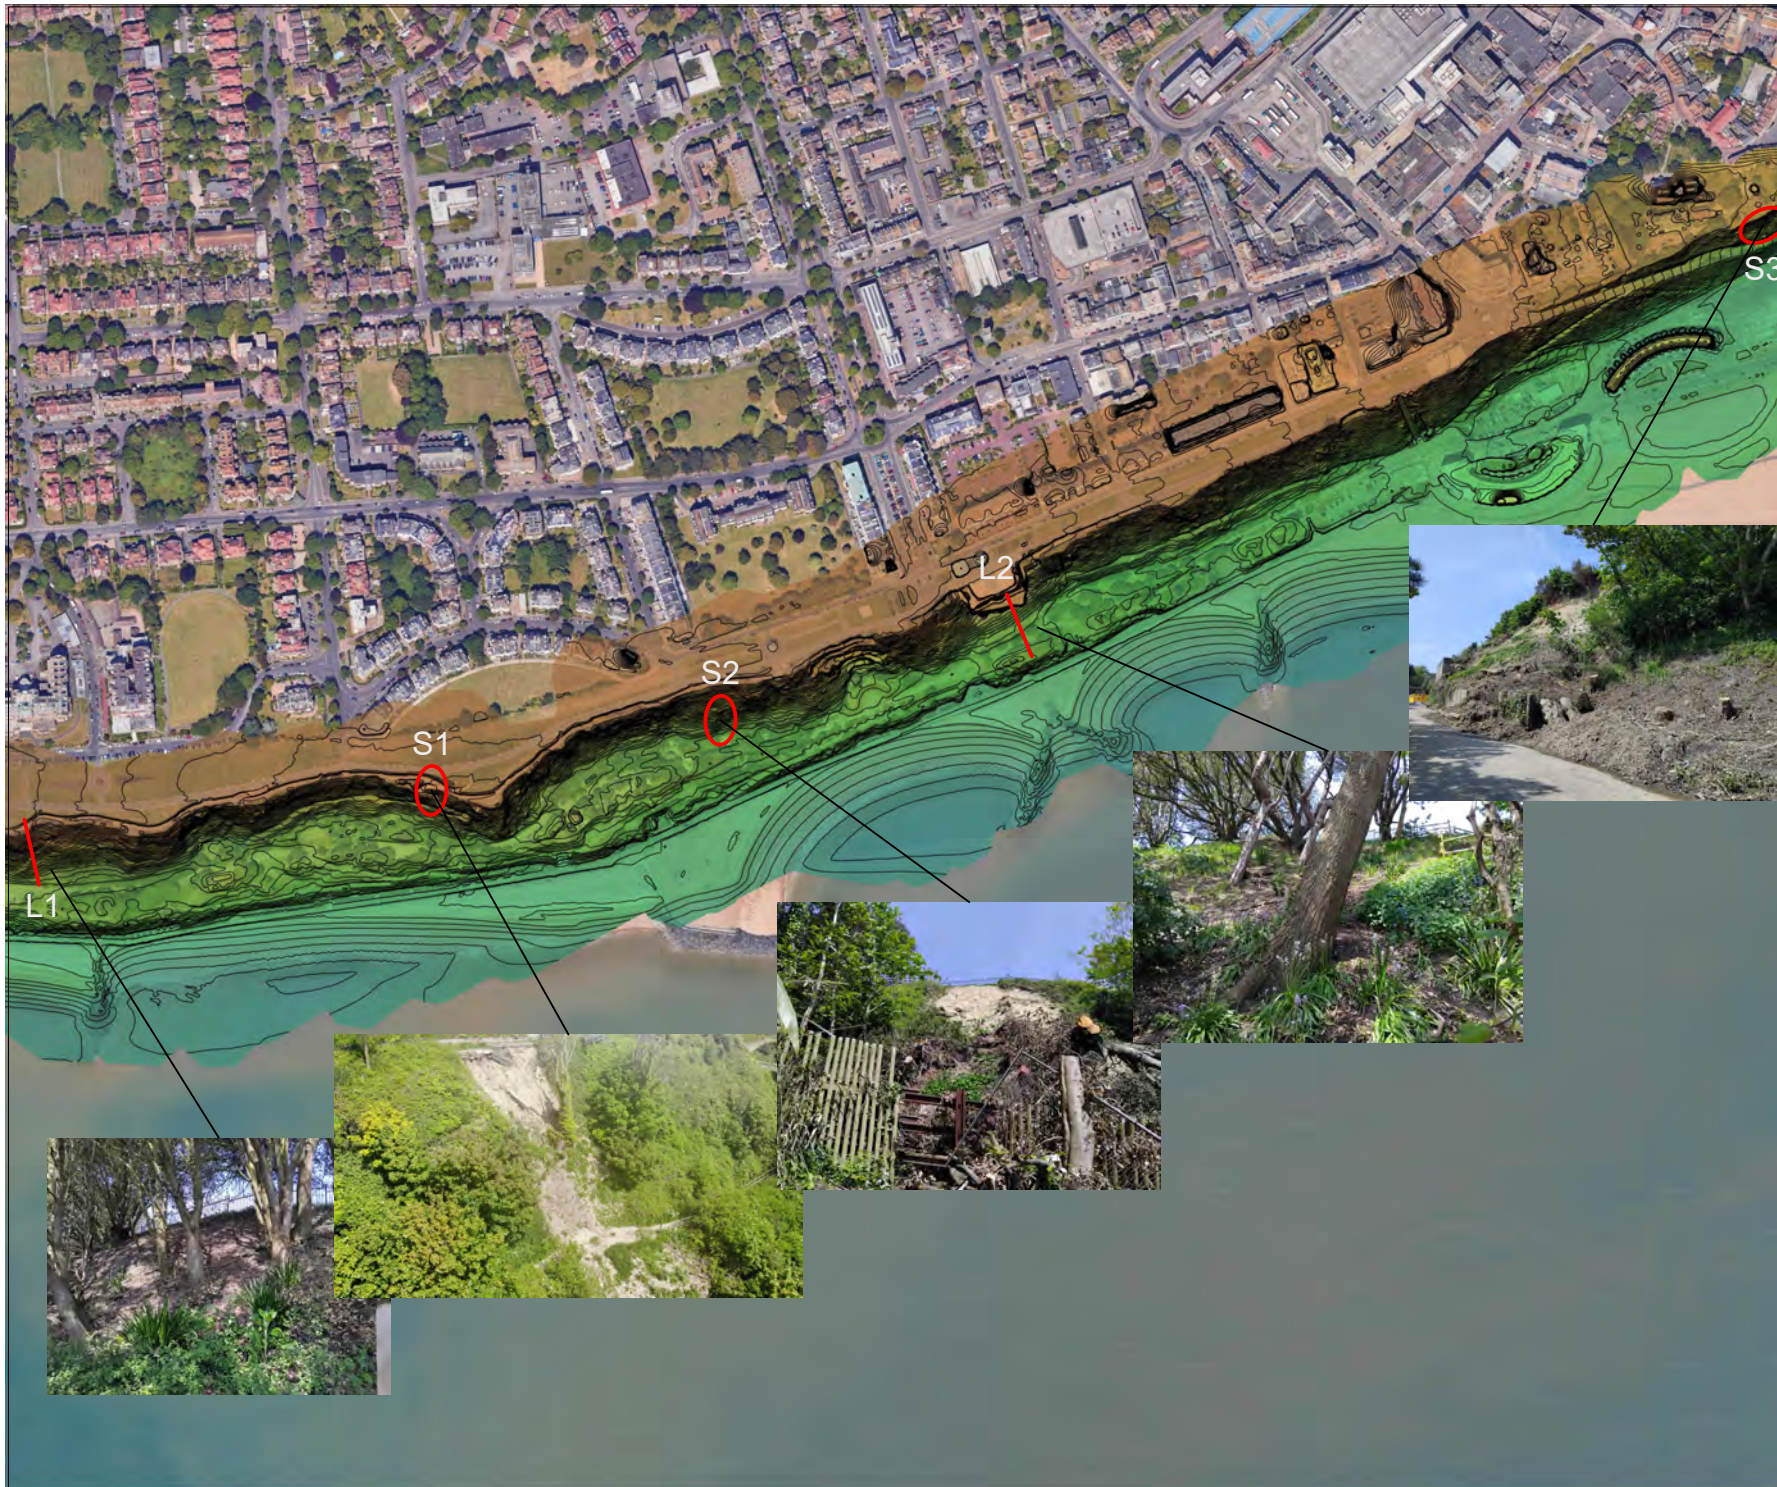
Title  
 Figure 2 - Locations of Recent Slips & Localities

Two notable failures, in the form of slips of the slope between the upper level and the coastal park, are understood to have occurred in recent times. One of these is located in the western part of the coastal park, south of Earls Avenue, at the top of and beyond the north of the promenade, this slip is henceforth referred to as S1 and detailed descriptions of the characteristics of S1 are presented in Section 3. The other slip (referred to as S2 throughout this report) between the promenade and the coastal park occurred more centrally within the western section of the coastal park, between the Adventure Playground on the northern side of Lower Sandgate Road and the footpath directly adjacent to a structure known as The Vinery / The Leas Esplanade adjacent to the promenade at the top of the slopes.

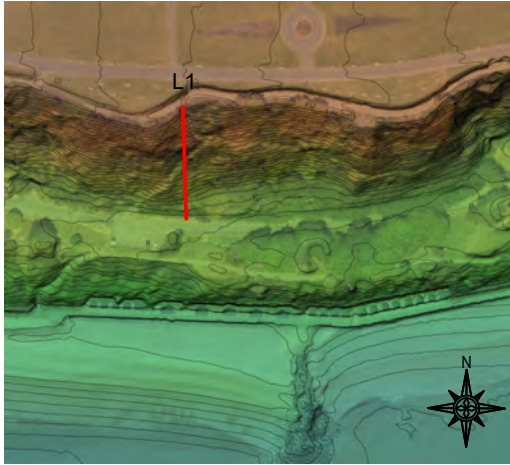
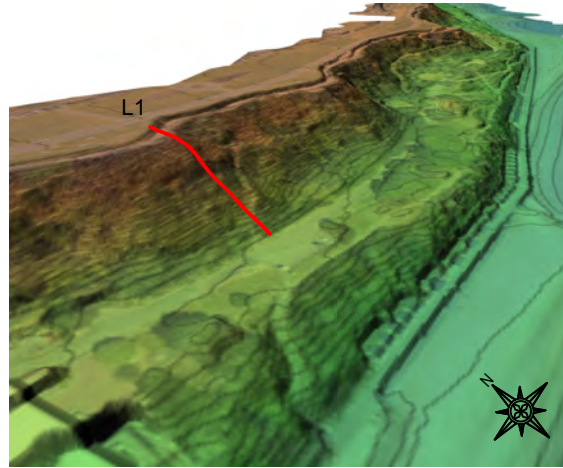
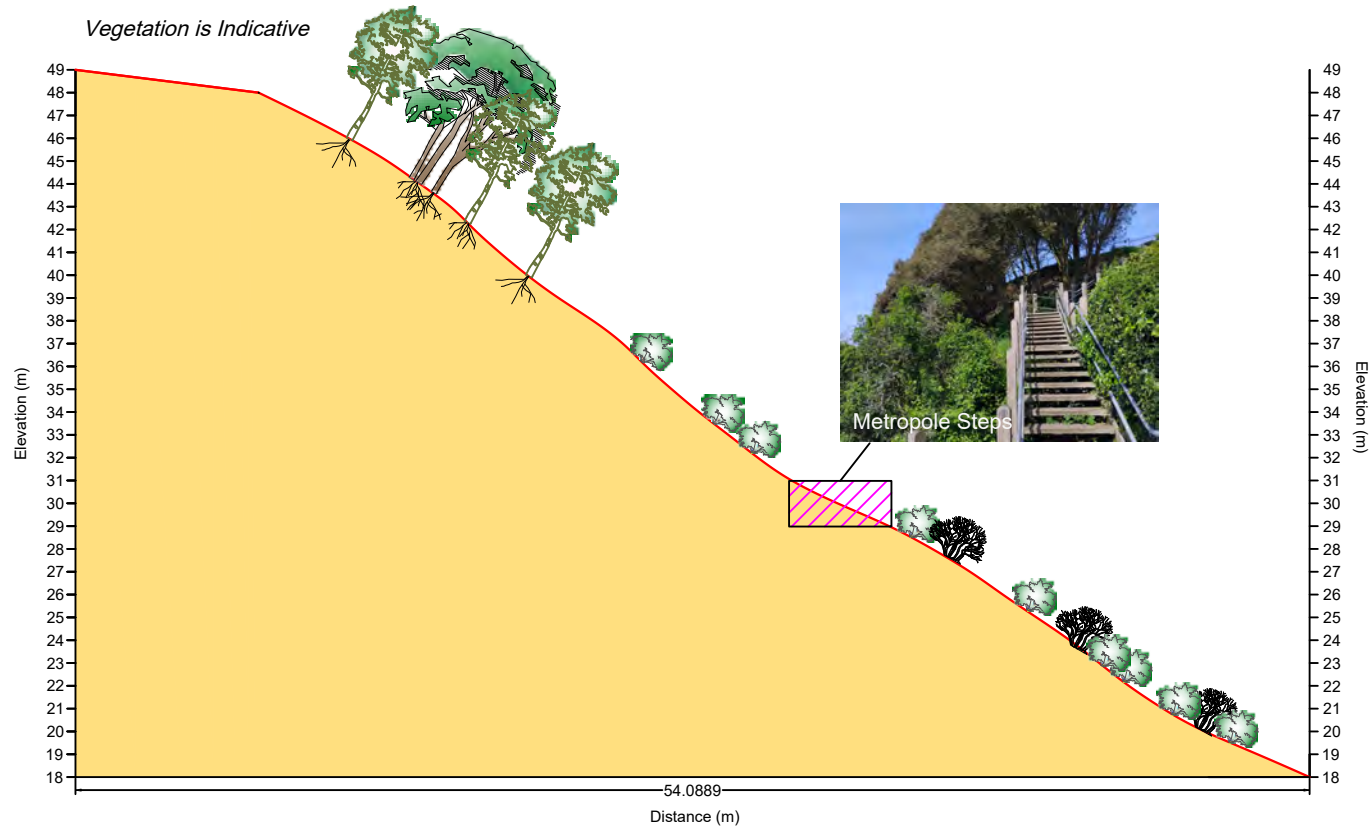
L1 is illustrated in Figure 3 and is located at the western extent of the coastal park adjacent to the staircase (known as The Metropole Steps) from Lower Sandgate Road to a footpath adjacent to the promenade at the top of the slope. Here the staircase extends northeast from Lower Sandgate Road to approximately two thirds the height of the slope before the staircase then changes direction to lead upwards to the northwest.

The steepness of the slope increases as you move up towards the promenade with the calculated slope profile in Figure 3 identifying a maximum angle of approximately 48 degrees in the area of 'loose soils' which could also contribute to instability. Photos 10 and 11 taken from 'L1' are presented below:

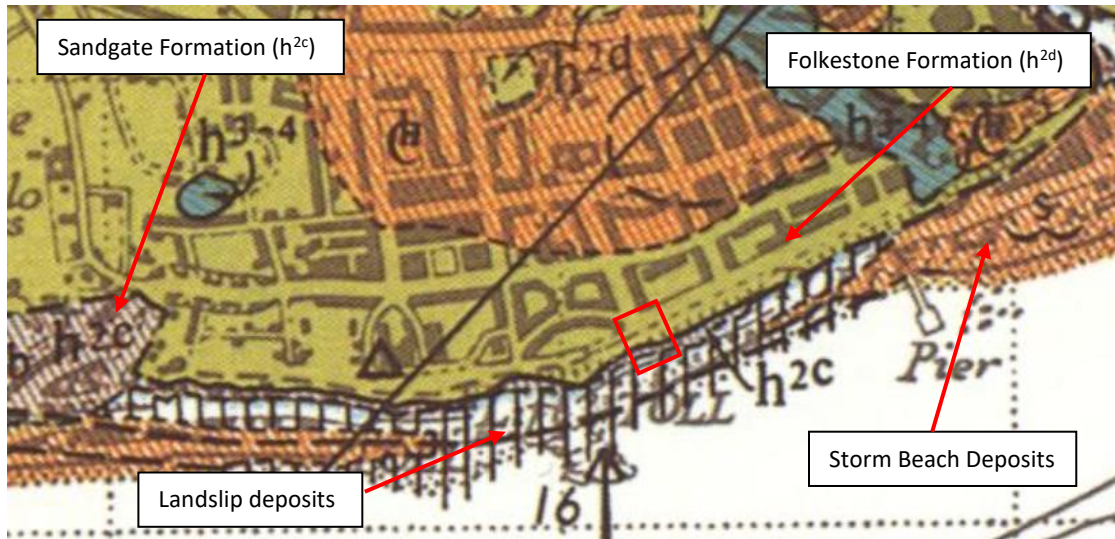
Figure 1. Local geology, solid and drift, from BGS Sheet No. 350 & 360. C08/084-CSL British Geological Survey ©NERC. All rights reserved.

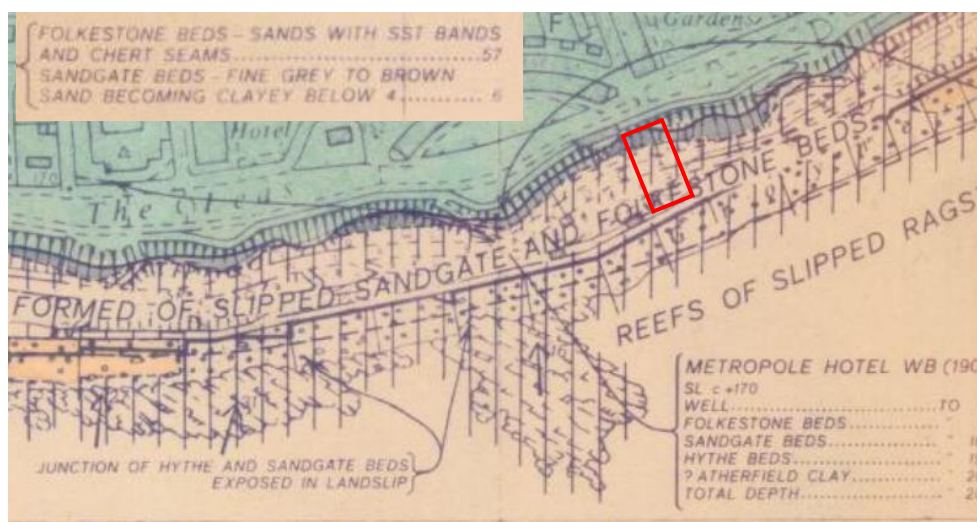
The large scale, 1:10,560 BGS map is TR23NW from 1967 which shows that the area where the Leas Park playground is located was formed of slipped Folkestone Formation and Sandgate Formations (Figure 2). The landslip occurred in 1784 upon which the park was founded. BGS GeoIndex Onshore online map indicates that the landslip material consists of sand, silt and clay.

Figure 2. BGS 1:10,560 scale map showing the area (red rectangular). C08/084-CSL British Geological Survey ©NERC. All rights reserved.

The junction between the Folkestone and Sandgate Formations is considered to be covered by the historical landslip material.

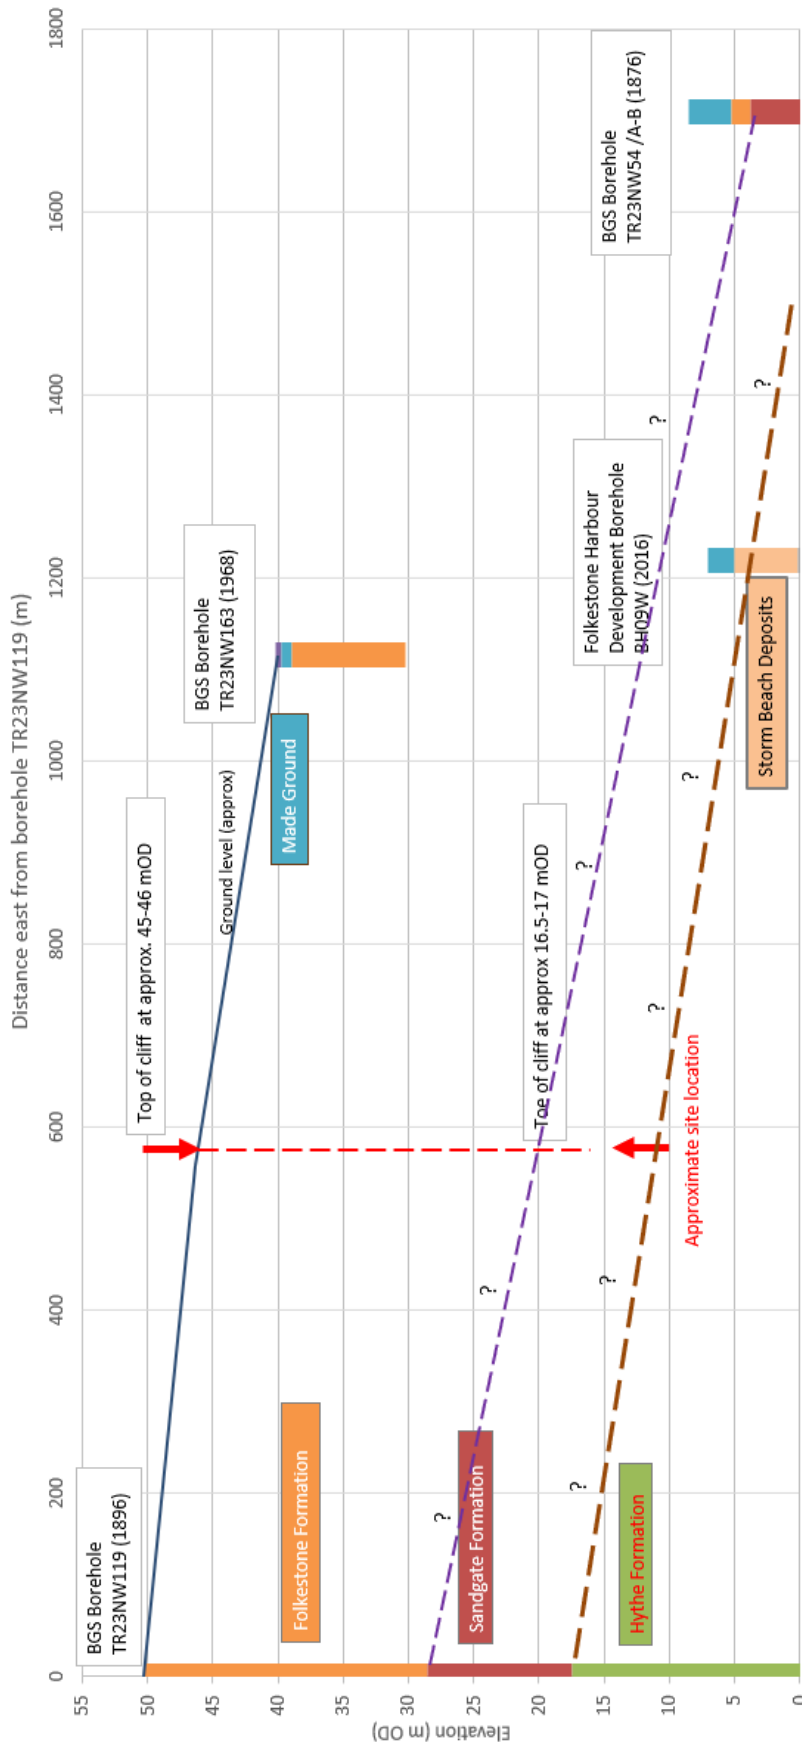
A stratigraphic cross section of the cliff can be found below in Figure 3. Due to difficulty of estimating the dip directions of the top of formations which can change a few metres vertically, it is not possible to clearly identify the Folkestone-Sandgate formations junctions.

Figure 3. Stratigraphic Cross Section of the Leas Cliff

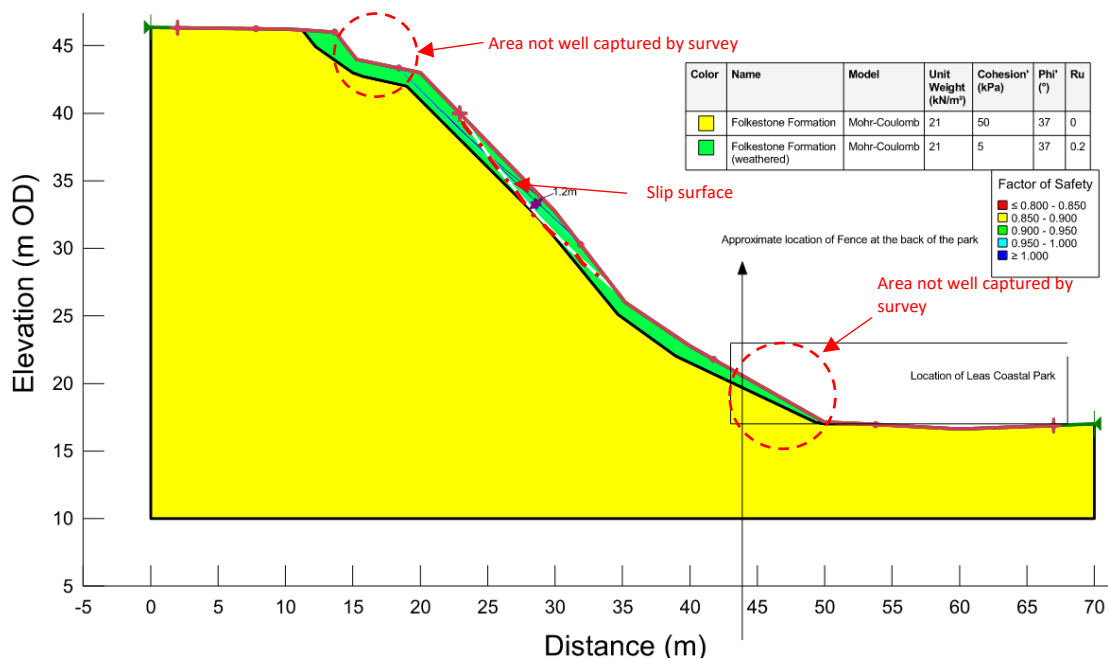
Slope/W model with shallow slip (around 1.2 m thick) with a factor of safety less than 1.0 can be seen within Figure 4.

Note that that the section used in the analysis is from drone topographical survey after the landslide. Poor resolution prevents to capture the detailed slope features. It also fails to correctly identify the location of the slope which should start just below the top of the cliff (shown with dashed circle in Figure 4). However, the slip circle identifies the areas below this section. Based on the site observations, this is also the area where the slip also occurred.

Figure 4. Input model for back-analysis.

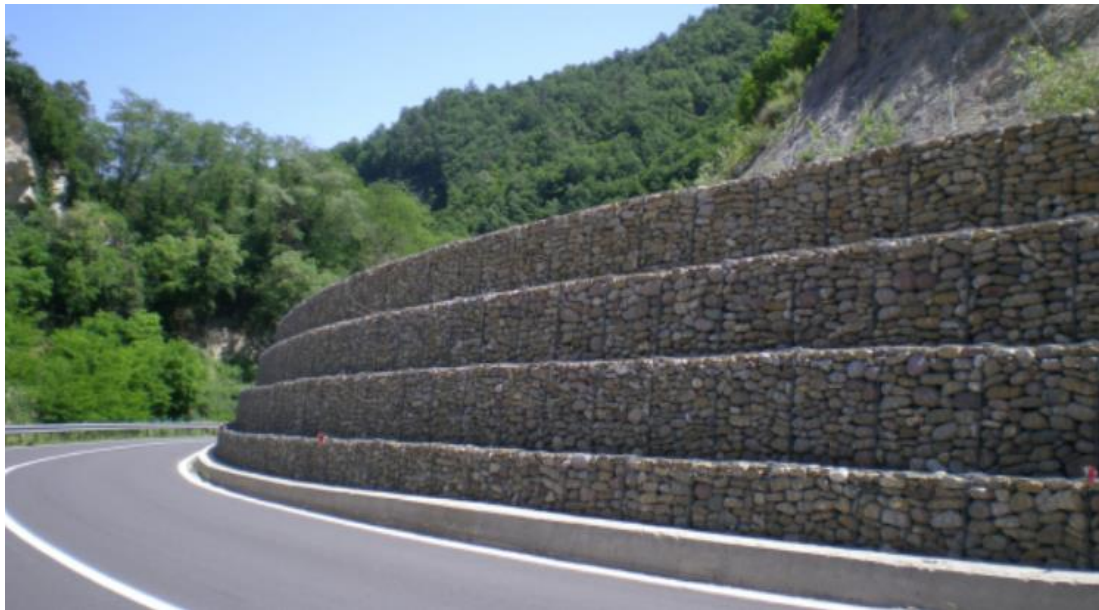
Photo 7. Gabion wall in front of a cliff (image taken from Maccaferri's website)

This option consisting of the placement of a gravity type retaining wall using gabion baskets or Legato® interlocking concrete blocks in front of the cliff. Building such wall will require a larger area at the base to provide sufficiently high wall, similar to the wall shown in Photo 7. A mass concrete foundation to place the units will be required to prevent uneven settlement along the wall. Some scaling of the cliff may be required to permit the placement on wall. The wall will be large in size to ensure that it does not fail if another landslide occurs at this location. There will be some space needed behind the top wall elements to collect any future landslip material. This option requires transport of large quantity of stones to fill the gabion baskets.

This option will still require reinforcement of the top of the cliff using soil nails.

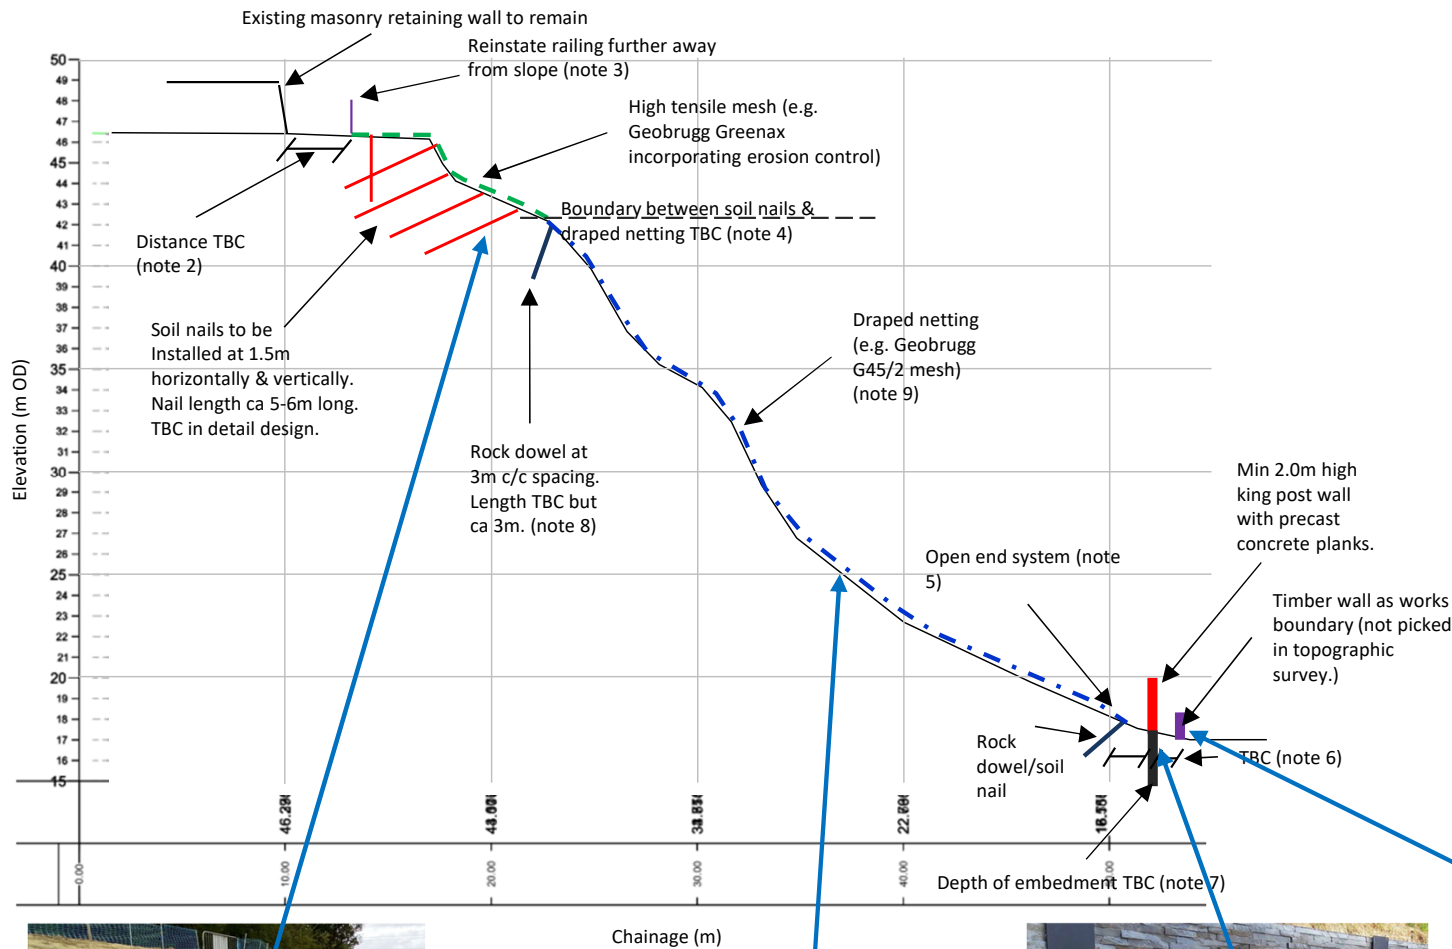
Date	Project No.	Drawing No.
15/10/2024	A124037	A124037-TG-SKE-CV-00001 Rev P01

- Notes:**
1. All dimensions are in millimetres unless otherwise specified.
  2. The width of the footpath (Madera Walk) may be reduced due to the slip and the top row of soil nails. Soil nails here can be buried within the new surfacing.

3. Railings to be reinstated away from the edge of the cliff due to cracks as a result of the landslide..
  4. The boundary where the soil nailing ends and drape netting starts will be decided following land-based topographical survey. The as-built location will be decided by contractor based on the condition of the cliff during works.

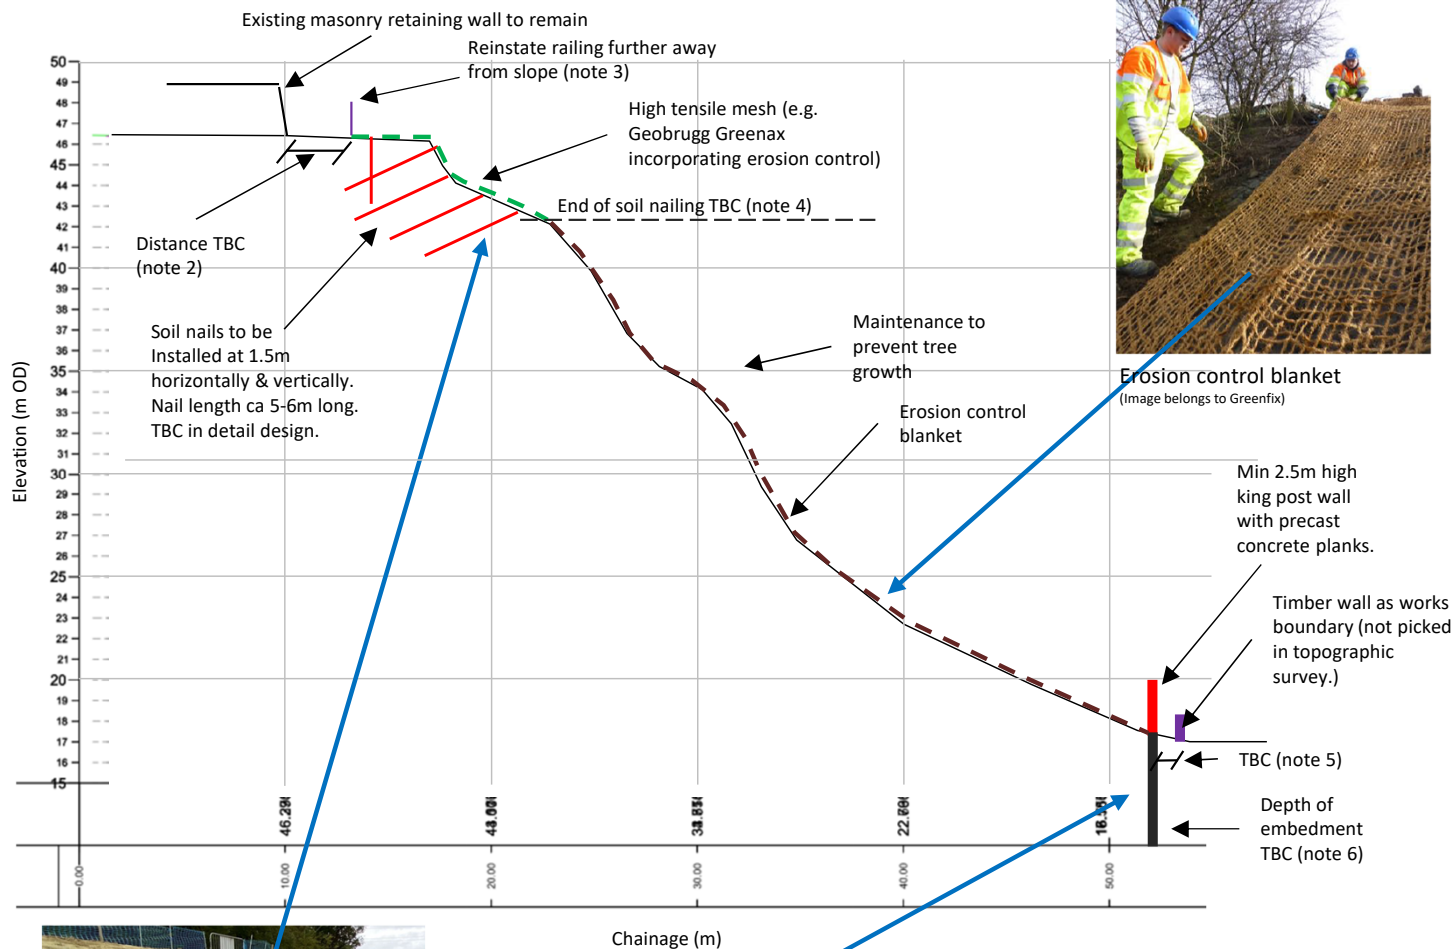
Date	Project No.	Drawing No.
15/10/2024	A124037	A124037-TG-SKE-CV-00002 Rev P01

3. Railings may need to be reinstated away from the edge of the cliff due to cracks as a result of the landslide.
4. The boundary where the soil nailing following land topographical survey. Final location will be decided by contractor based on the condition of the cliff during works.

5. Distance between the king-post wall and the boundary timber wall will be confirmed once the option is taken forward.
6. At this location, the founding ground is assumed to be landslip material because of historical landslips. Depth of foundation to be confirmed once a ground investigation is carried out. However, due to possible softer nature of landslip material at this location and larger kinematic energy of landslip material, the wall will be bigger and will require posts to be embedded deeper into the bedrock.

**Option 2a – Soil nailing and heavy  
king-post retaining wall**

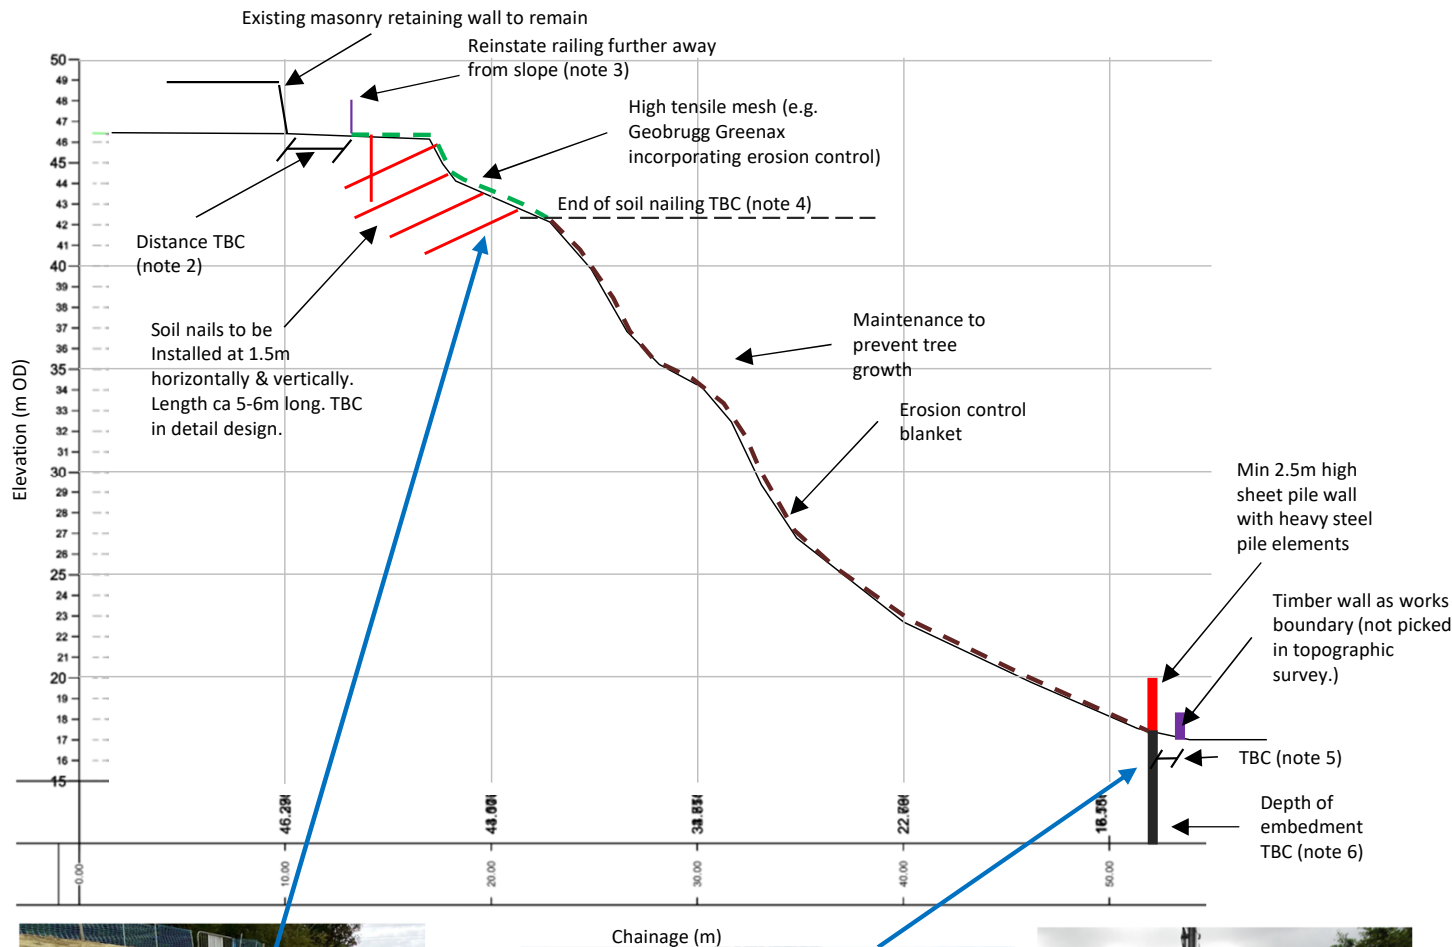
Date	Project No.	Drawing No.
15/10/2024	A124037	A124037-TG-SKE-CV-00003 Rev P01

1. All dimensions are in millimetres unless otherwise specified.
2. The width of the footpath (Maderia Walk) may be reduced due to the slip and the top row of soil nails. Soil nails here can be buried within the surfacing.

3. Railings may need to be reinstated away from the edge of the cliff due to cracks as a result of the landslide.
4. The boundary where the soil nailing following land topographical survey. The as-built location will be decided by contractor based on the condition of the cliff during works.

5. Distance between steel sheet pile wall and the boundary timber wall will be confirmed once the option is taken forward.
6. At this location, the founding ground is assumed to be landslip material because of historical landslips. Depth of foundation to be confirmed once a ground investigation is carried out. However, due to possible softer nature of landslip material at this location and larger kinematic energy of landslip material, the wall will be bigger and will require posts to be embedded deeper into the bedrock.
